Appendix N Exceedance Report

Statistical Summary of Exceedances in the Reporting Period

Project	Integrated Waste Management Facilities, Phase 1		
Date	2 Feb 2021 (Lab result received on 5 Feb 2021)		
Time	14:12 – 17:42 (Mid-Ebb) 08:15 – 11:45 (Mid Flood)		
Mid-Ebb			
Monitoring Location	B2, F1A, H1, CR2

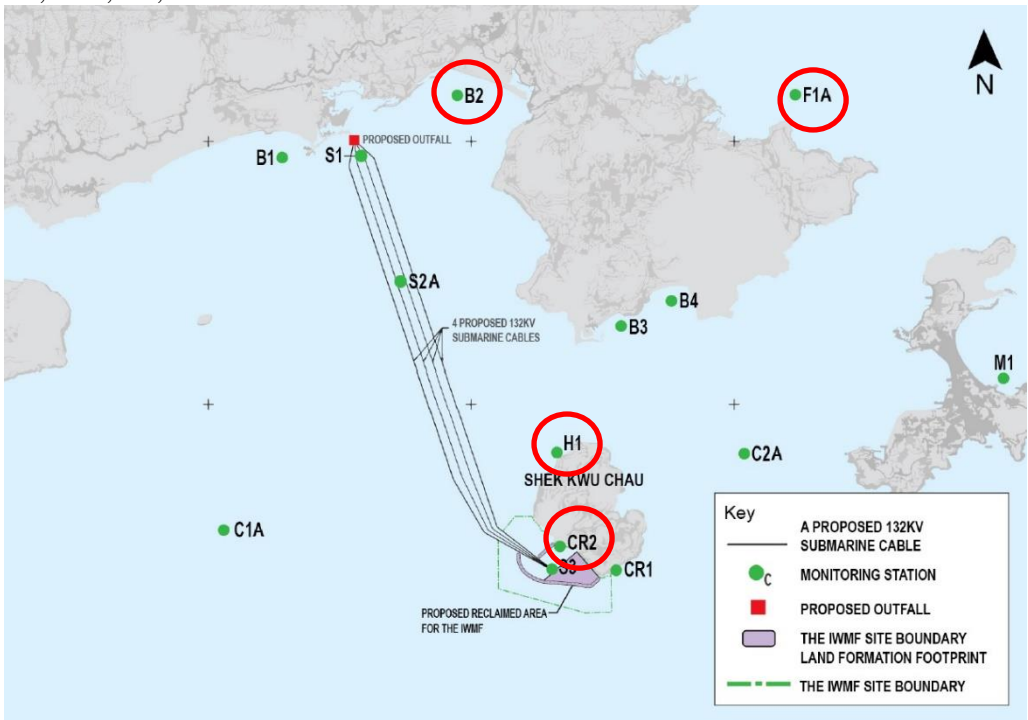
Parameter	Suspended Solid (SS)		
Action & Limit Levels	Action Level		Limit Level
	≥ 8.0 mg/L		≥ 10.0 mg/L
Measurement Level	Impact Station(s) of Exceedance	Control Stations	Impact Station(s) without Exceedance

9.0 mg/L (B2) 9.0 mg/L (F1A) 9.5 mg/L (H1) 8.3 mg/L (CR2)	5.3 mg/L (C1A) 9.3 mg/L (C2A)	4.5 mg/L (B1) 5.5 mg/L (B3) 4.8 mg/L (B4) 7.2 mg/L (M1) 5.0 mg/L (CR1)
Possible reason for Action or Limit Level Non-compliance	<p>Works scheduled on site on 2 Feb 2021 include reclamation works, laying of rockfill and caisson installation.</p> <p>Dominating sea current direction was found to be from Northwest to Southeast at waters around Shek Kwu Chau.</p> <p>B2, F1A and H1 are located at unrelated stream direction neither upstream nor downstream, far away) to the works location, exceedance of this monitoring station is deemed to be unrelated to the Project.</p> <p>CR2 is located close to the works location within the Project site while Silt curtain checking by the Contractor was implemented on Marine Access (2 Feb 2021, 10:00am) and checking results showed that no deficiency of silt curtain was found on that day.</p> <p>From MMO monitoring records on 2 Feb 2021, MMO team was arranged for one</p>

crane barge (金盈 8), silt curtain at western marine access area on that day while no deficiency of silt curtain was found before the commencement of and during construction activity.

According to the field observation by Marine Mammal Observer team & sampling team during sampling event, no silt plume was observed in the Project site.

Site tidiness in the present barges in the Project site were checked during weekly site inspection on 27 Jan 2021. No major observation of improper site practices that could contribute to the increase of the suspended solids recorded.

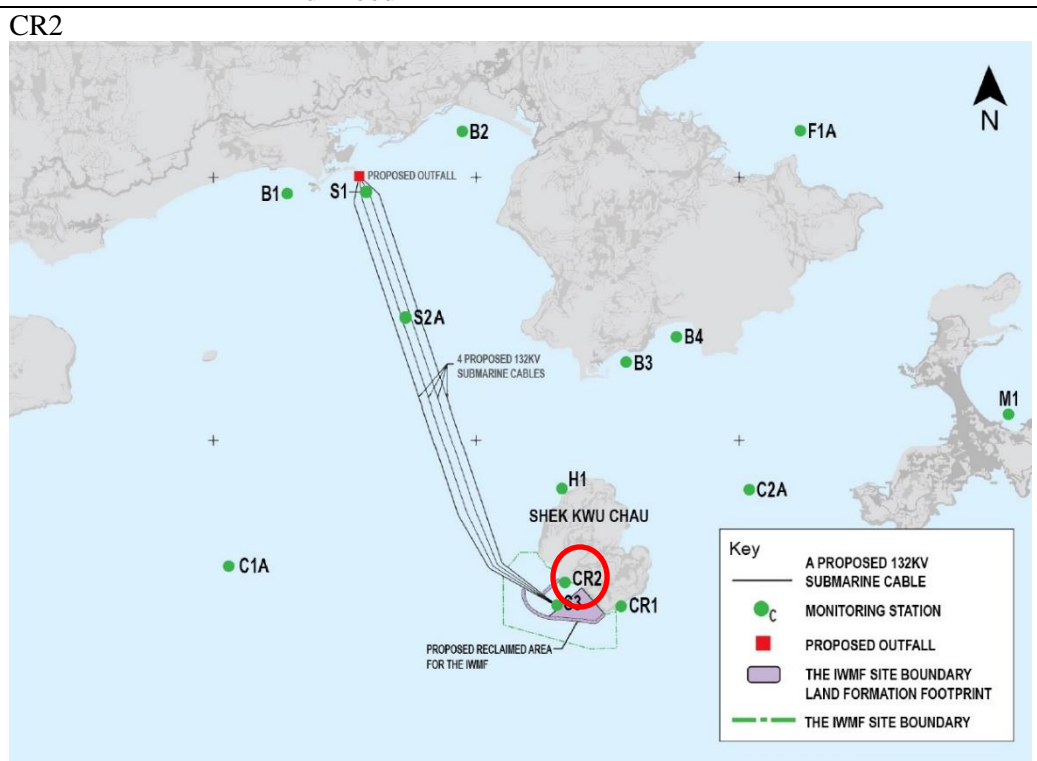
Monitoring Location

Measurement Level	Impact Station(s) of Exceedance	Control Stations	Impact Station(s) without Exceedance
		8.7 mg/L (CR2)	5.3 mg/L (C1A) 5.7 mg/L (C2A)

Works scheduled on site on 2 Feb 2021 include reclamation works, laying of rockfill and caisson installation.

Dominating sea current direction was found to be from Southeast to Northwest at waters around Shek Kwu Chau.

CR2 is located close to the works location within the Project site while Silt curtain checking by the Contractor was implemented on Marine Access (2 Feb 2021, 10:00am) and checking results showed that no deficiency of silt curtain was found on

<p>that day.</p> <p>From MMO monitoring records on 2 Feb 2021, MMO team was arranged for one crane barge (金盈 8), silt curtain at western marine access area on that day while no deficiency of silt curtain was found before the commencement of and during construction activity.</p> <p>According to the field observation by Marine Mammal Observer team & sampling team during sampling event, no silt plume was observed in the Project site.</p> <p>Site tidiness in the present barges in the Project site were checked during weekly site inspection on 27 Jan 2021. No major observation of improper site practices that could contribute to the increase of the suspended solids recorded.</p>
<p>Actions taken / to be taken</p>	<p>Examination of environmental performance of the Project will be continued during the weekly inspection, and the Contractor is reminded to implement all applicable mitigation measures as per the Updated EM&A Manual.</p>

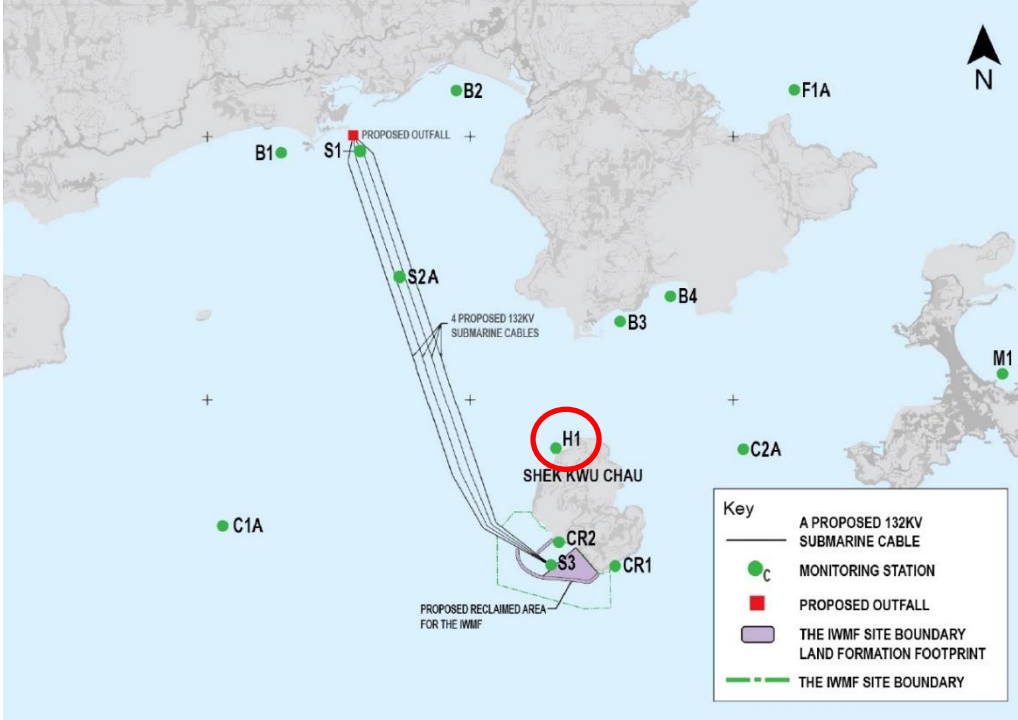
Parameter	Suspended Solid (SS)		
Action & Limit Levels	Action Level		Limit Level
	≥ 9.0 mg/L (120% of C1A)		≥ 10.0 mg/L
Measurement Level	Impact Station(s) of Exceedance	Control Stations	Impact Station(s) without Exceedance

9.3 mg/L (H1)	7.5 mg/L (C1A) 7.8 mg/L (C2A)	6.5 mg/L (B1) 8.5 mg/L (B2) 8.0 mg/L (B3) 7.5 mg/L (B4) 8.0 mg/L (F1A) 7.7 mg/L (M1) 7.7 mg/L (CR1) 8.5 mg/L (CR2)
Possible reason for Action or Limit Level Non-compliance	<p>Works scheduled on site on 18 Feb 2021 include reclamation works, laying of rockfill and caisson installation.</p> <p>Dominating sea current direction was found to be from Northwest to Southeast at waters around Shek Kwu Chau.</p> <p>H1 is located at unrelated stream direction (neither upstream nor downstream, far away) to the works location, exceedance of this monitoring station is deemed to be unrelated to the Project.</p> <p>Silt curtain checking by the Contractor was implemented on Marine Access (18 Feb 2021, 10:30am) and checking results showed that no deficiency of silt curtain was found on that day.</p>

From MMO monitoring records on 18 Feb 2021, MMO team was arranged for one derrick barge (DL5) and silt curtain at western marine access area on that day while no deficiency of silt curtain was found before the commencement of and during construction activity.

According to the field observation by Marine Mammal Observer team & sampling team during sampling event, no silt plume was observed in the Project site.

Site tidiness in the present barges in the Project site were checked during weekly site inspection on 17 Feb 2021. No major observation of improper site practices that could contribute to the increase of the suspended solids recorded.

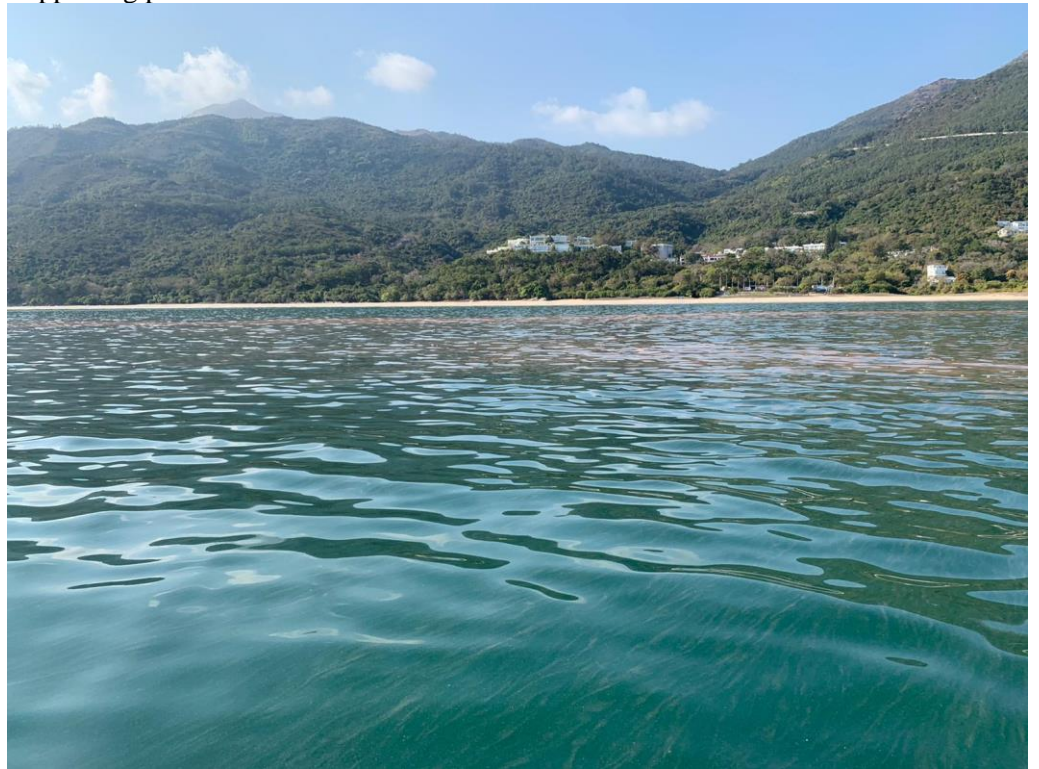
Supporting photo 1:

According to the field observation by Marine Mammal Observer team & sampling team during sampling event, no silt plume was observed in the Project site. However, widely spread reddish suspended particles resembling the look of red tide was observed by water sampling team near B1 (Supporting photo 1), if such was actually red tide, the algae could possibly induce the exceedance of SS level at B1.
