## Appendix N Exceedance Report

**Incident Report on Action Level or Limit Level Non-compliance**

Project	Integrated Waste Management Facilities, Phase 1		
Date	30 October 2024 (Lab result received on 6 November 2024)		
Time	15:30 – 19:00 (Mid-Flood)		
Monitoring Location	Mid-Flood B1, B2, B3, M1		
Parameter	Suspended Solid (SS)		
Action & Limit Levels	Action Level		Limit Level
	≥ 8.0 mg/L		≥ 10 mg/L
Measurement Level	Impact Station(s) of Exceedance	Control Stations	Impact Station(s) without Exceedance
	10.0 mg/L (B1) 8.1 mg/L (B2) 9.2 mg/L (B3) 10.3 mg/L (M1)	5.6 mg/L (C1A) 5.7 mg/L (C2A)	6.8 mg/L (B4) 4.9 mg/L (F1A) 6.3 mg/L (H1) 4.9 mg/L (CR1) 4.9 mg/L (CR2)
Possible reason for Action or Limit Level Non-compliance	As reported by the Contractor, no marine construction work was carried out and no surface runoff was observed on 30 October 2024. The photo records of sea surface adjacent to the Project Site provided by the Contractor are given below:

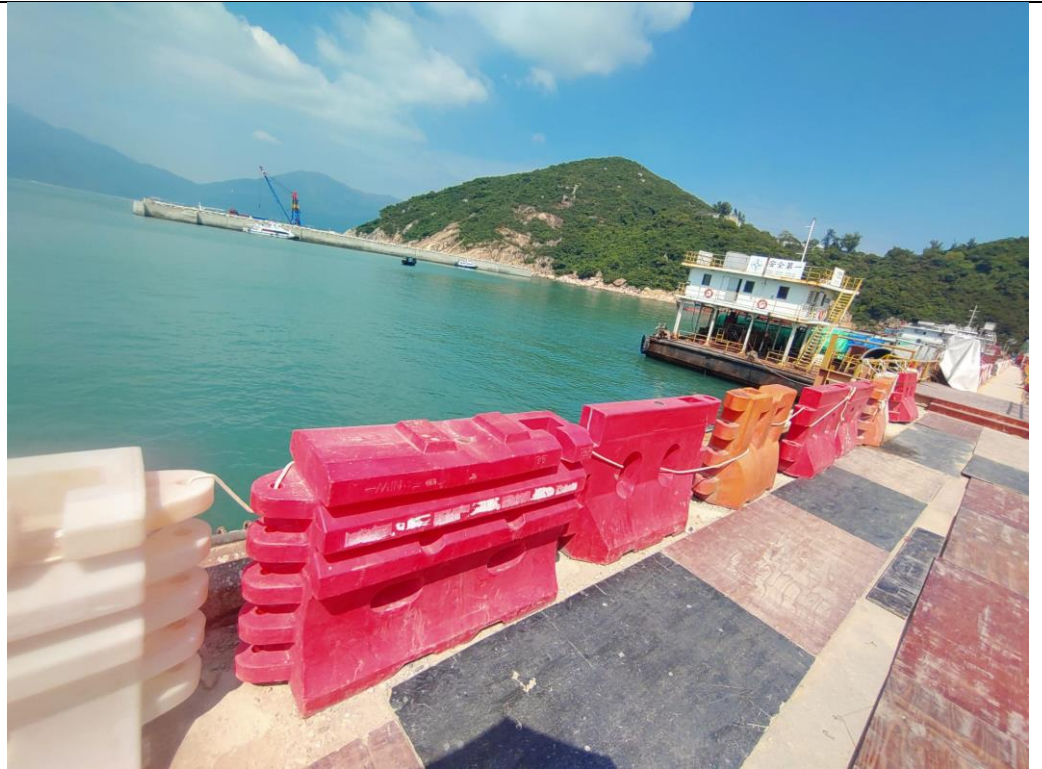
**Photo Record of Sea Surface adjacent to the Project Site (Viewpoint 1)**

<p>According to the field observation by sampling team during sampling event, no silt plume was observed in the Project site.</p> <p>No major observation of improper site practices that contributed to the increase of the suspended solids was recorded during the weekly site inspection on 29 October 2024.</p> <p>After the investigation, the exceedances on 30 October 2024 at B1, B2, B3 and M1 are deemed to be unrelated to the Project.</p>
<p>Monitoring photos of stations with exceedance</p>	<p>B1:</p>

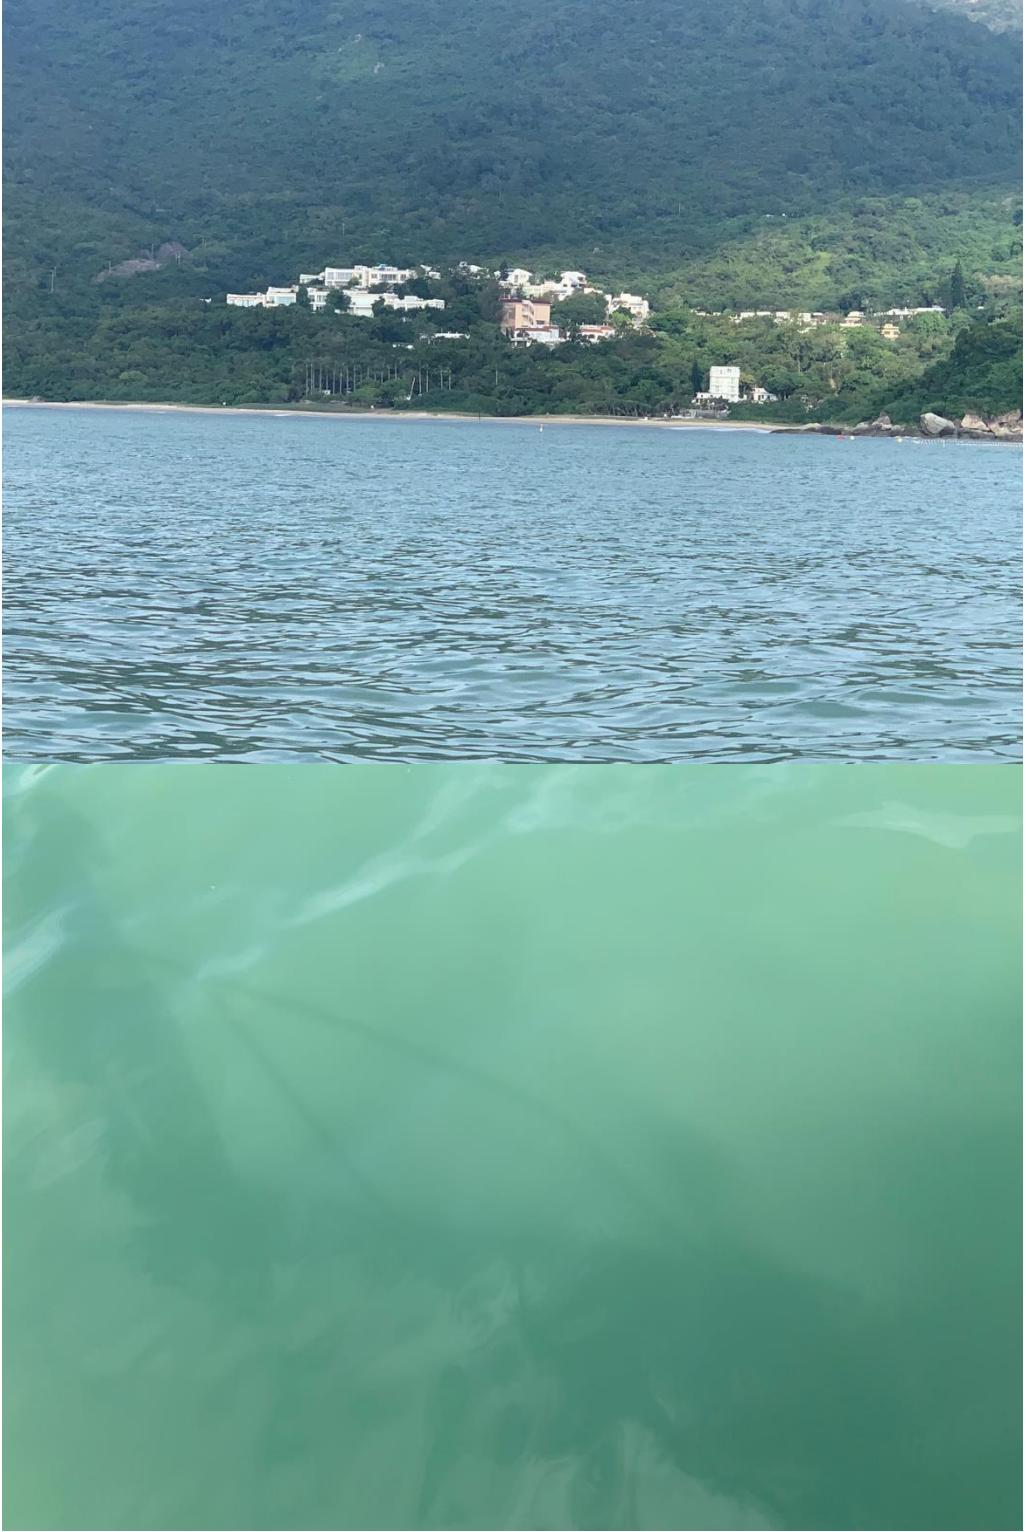
Exceedances of action level were found at B2 and B3 while exceedances of limit level were found at B1 and M1. B1, B2, B3 and M1 are located at unrelated stream direction (neither upstream nor downstream) to the works location. Exceedances at the monitoring stations are deemed to be unrelated to the Project.

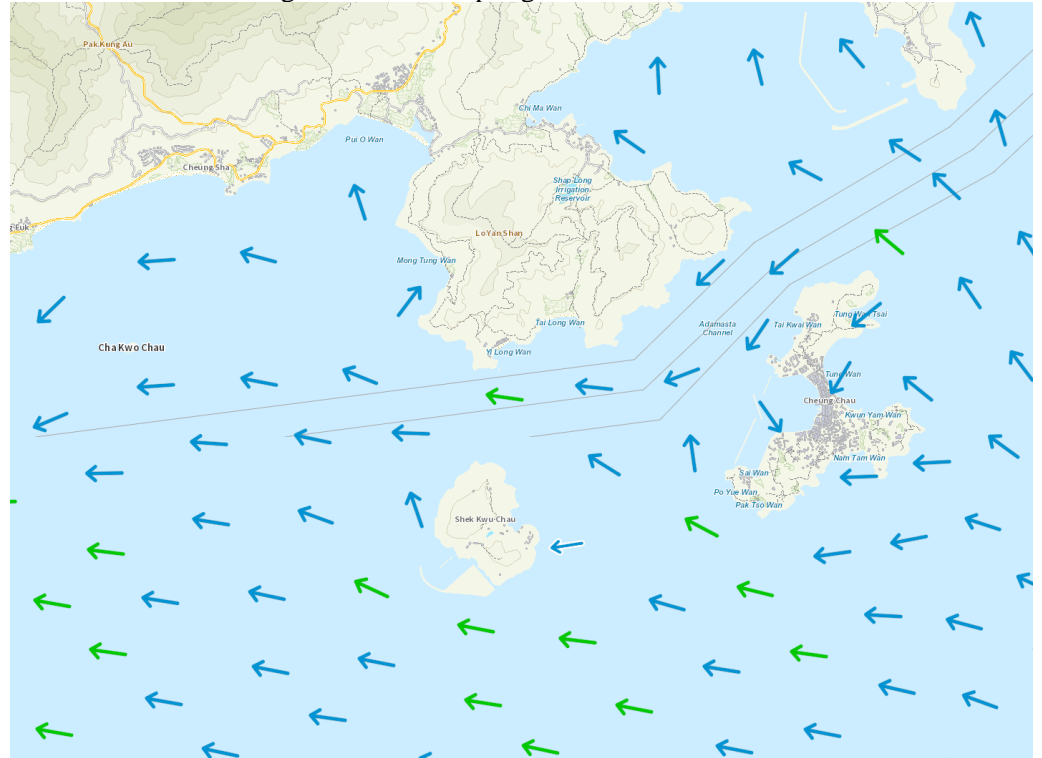
Current direction during mid-flood sampling on 30 October 2024:

Dominant sea current direction was found to be from Southeast to Northwest at waters around Shek Kwu Chau.
