Contract No. EP/SP/66/12
Integrated Waste Management Facilities, Phase 1

Quarterly EM&A Report No.1 (Period from 28 June to 30 September 2018)

(Clause 3.3, Further Environmental Permit FEP-01/429/2012/A)

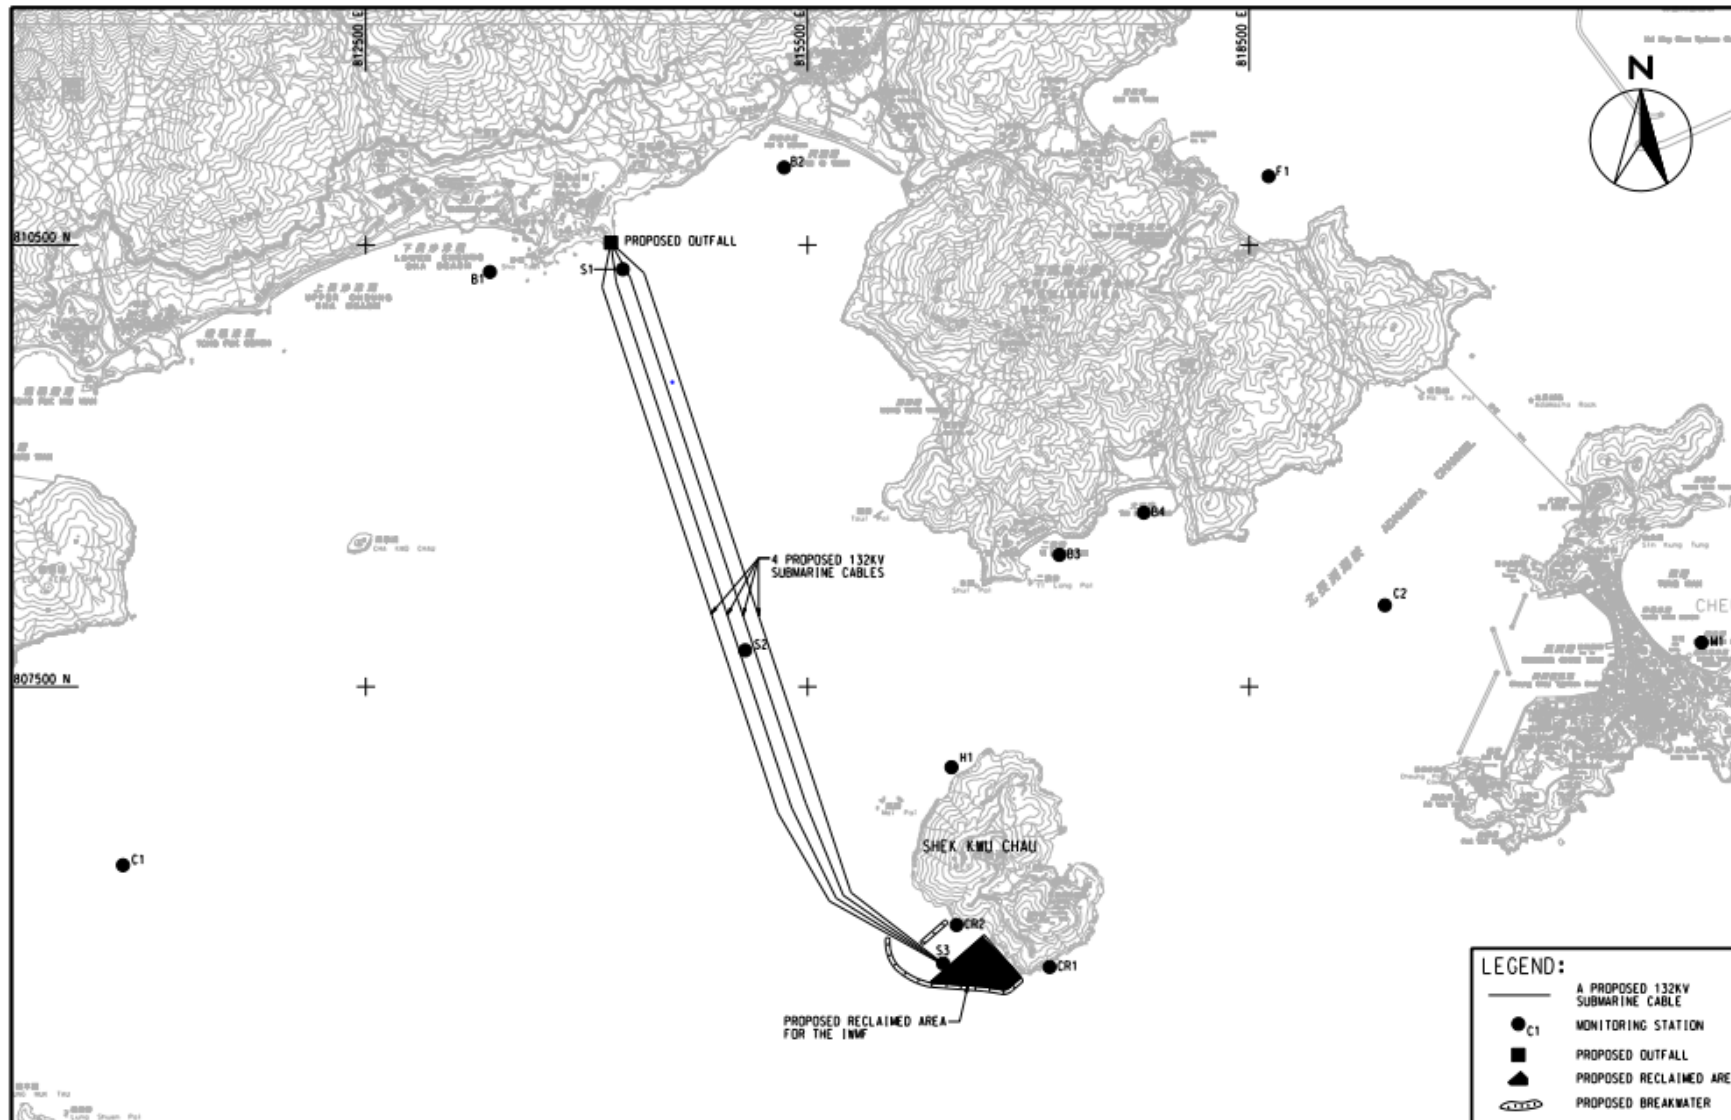
Figure 2.1 Water monitoring locations at Artificial Island near SKC

- 2.2.1 Impact water quality monitoring was conducted at eleven monitoring locations during general water quality monitoring and fourteen water monitoring locations during regular DCM monitoring, as shown in **Figure 2.1**.

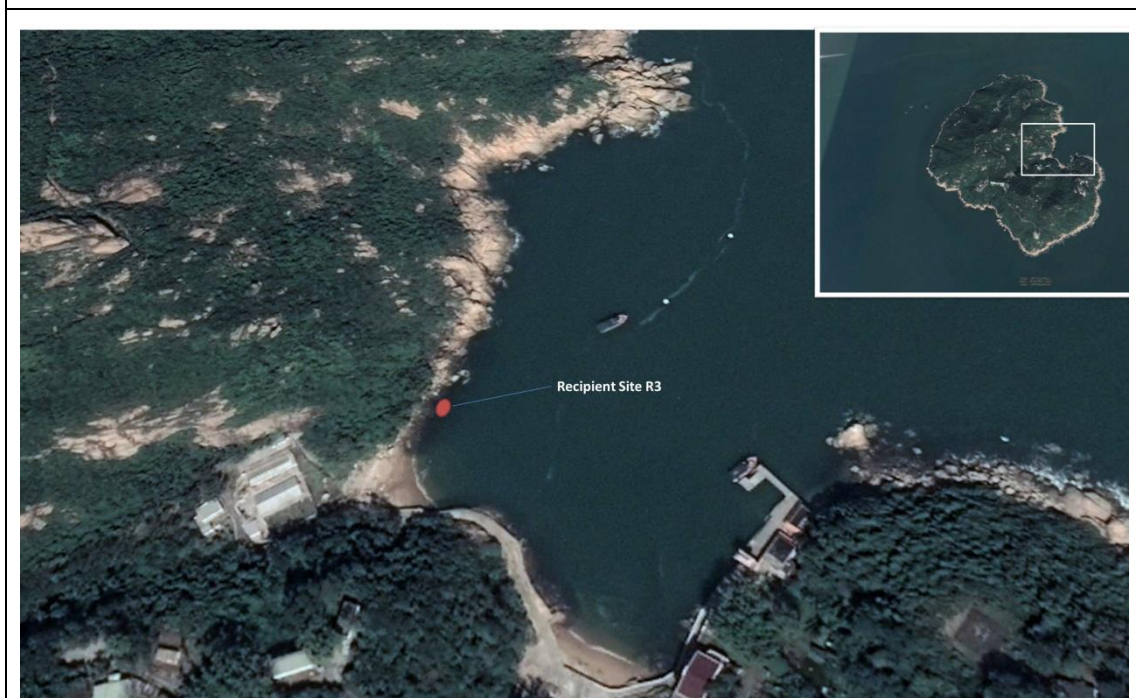
Figure 5.3 Tagged Translocation Corals at Recipient Site R3 near SKC

Location of the ten tagged coral colonies at each of the proposed indirect impact site, control site and the recipient site R3 are shown in **Figure 5.1**, **Figure 5.2**, **Figure 5.3** and **Figure 5.4** respectively:

5.4.3 The first and second Post-translocation Monitoring was performed on 26th June 2018 and 20th September 2018 respectively for the Recipient Site R3 (**Figure 5.3**) and the weather conditions were summarized in **Table 5.4**.

- 5.4.9 The second post-translocation coral monitoring was carried out on 20 September 2018. Sixteen (16) movable hard coral colonies were monitored at the recipient site R3. However, 9 translocated coral colonies were missing during the second monitoring survey and only 7 left (**Table 5.7**). The remaining translocated coral colonies also showed an increased mortality from 5% to 15% (**Table 5.7**). The missing colonies probably were swept away by the strong wave action caused by the Super Typhoon Mangkhut hitting Hong Kong on 15th and 16th September 2018.

- 5.4.11 Since all missing tagged coral colonies at the Recipient Site R3 were caused by the Super Typhoon Mangkhut, the AL/LL will not be applied at this time. Post-translocation monitoring survey will be continued to monitor the remaining tagged coral colonies for both translocated coral and natural coral colonies.

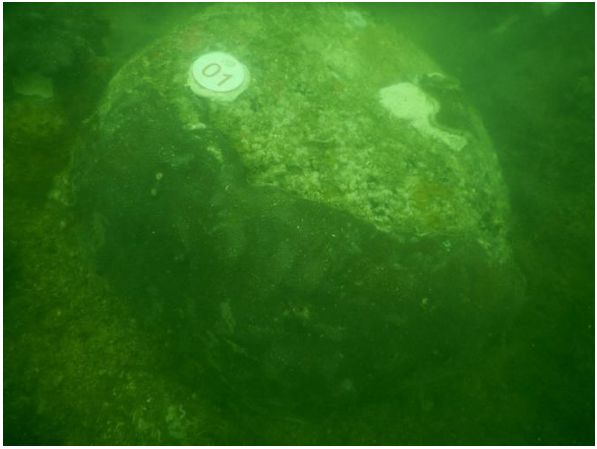
Tag #	Baseline	26-June	20-September
1

A circular white tag with the number '01' is attached to a large, rounded coral specimen. The coral is covered in a dense layer of green algae or other organisms. The background is dark green.

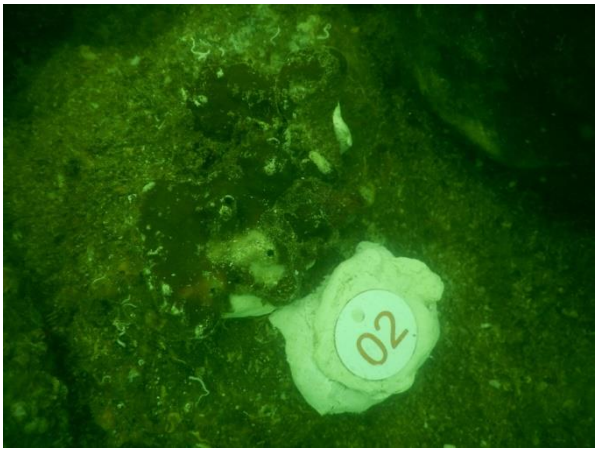
A circular white tag with the number '02' is attached to a coral specimen. The coral is heavily encrusted with green and brownish organisms. The background is dark green.

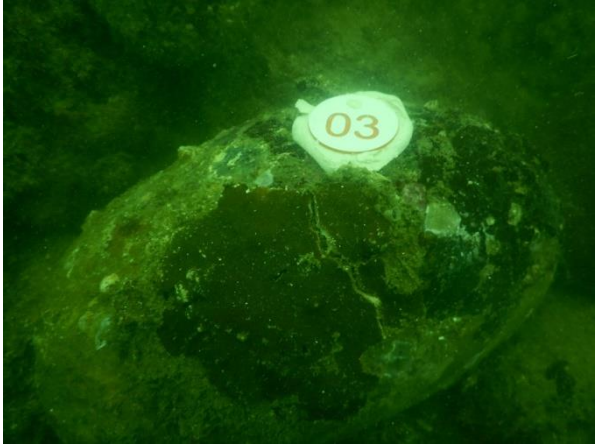
Tag #	Baseline	26-June	20-September
3

A close-up photograph of a white circular tag with the number '03' in red, attached to a dark, textured rock surface. The background is dark green.

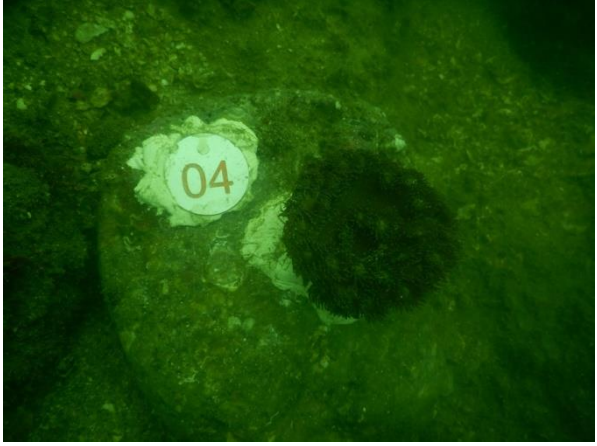
A close-up photograph of a white circular tag with the number '04' in red, attached to a dark, textured rock surface. The background is dark green.

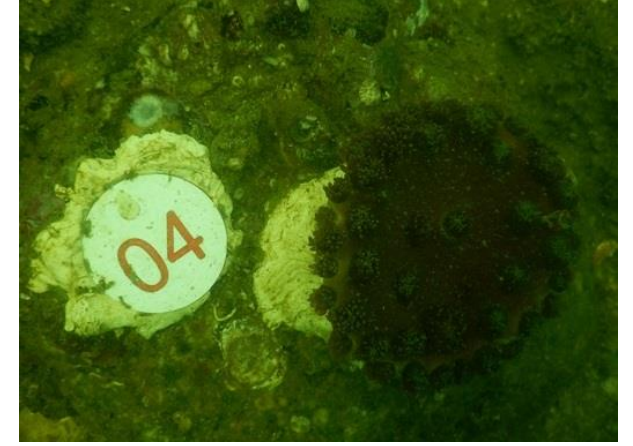
A close-up photograph of the same tag '04' on the rock, showing significant dark, fuzzy growth covering the tag and surrounding area. The background is dark green.

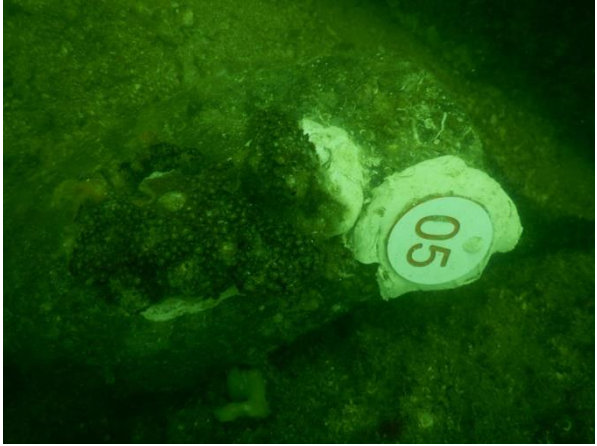
Tag #	Baseline	26-June	20-September
5

A close-up photograph of a white circular tag with the number '05' printed on it. The tag is attached to a light-colored, irregularly shaped object, possibly a piece of coral or a rock, which is partially covered in dark green algae. The background is a dark, murky green.

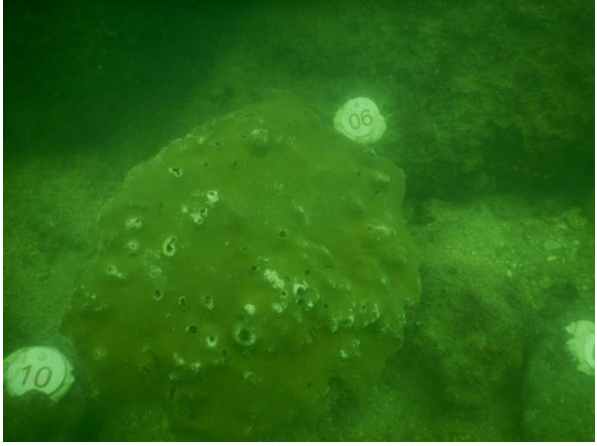
A photograph of a light-colored, irregularly shaped object, possibly a piece of coral or a rock, covered in dark green algae. Two white circular tags are visible: one with the number '06' and another with the number '10'.

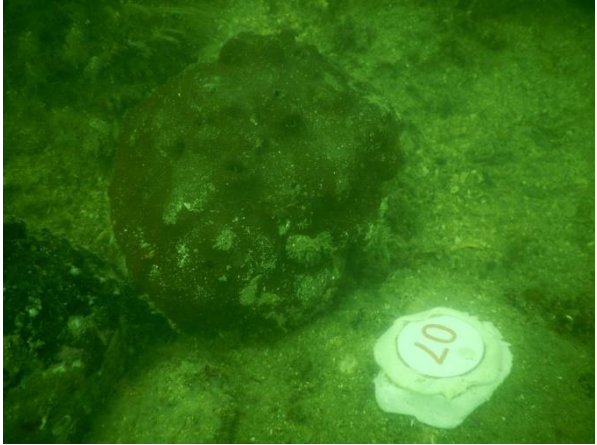
Tag #	Baseline	26-June	20-September
7

Underwater photograph showing a white tag with the number '07' on a dark, rocky substrate. The tag is positioned in the lower right quadrant of the frame.

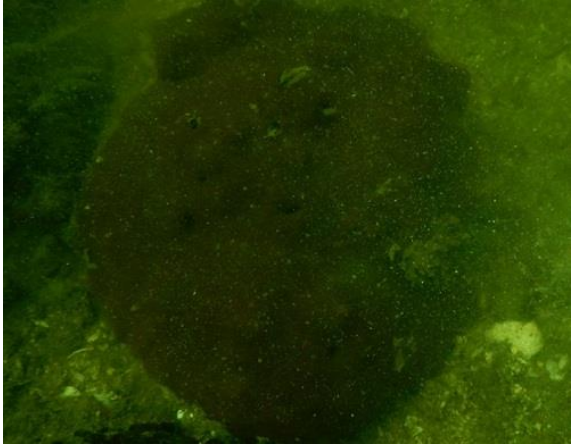
Underwater photograph showing a dark, irregularly shaped object on a rocky substrate. The tag is not clearly visible.

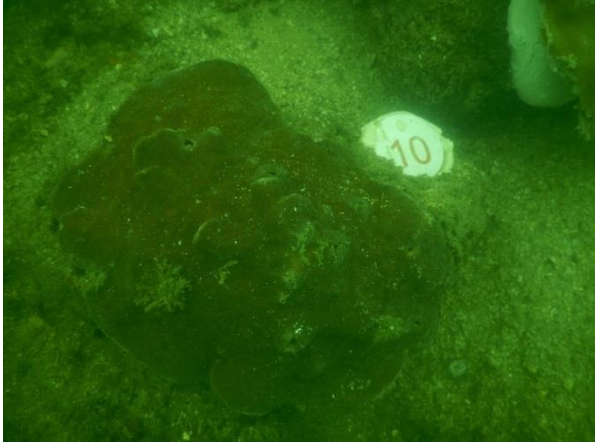
A photograph showing a circular tag with the number '10' on a dark, textured surface. The tag is white with black numbers.

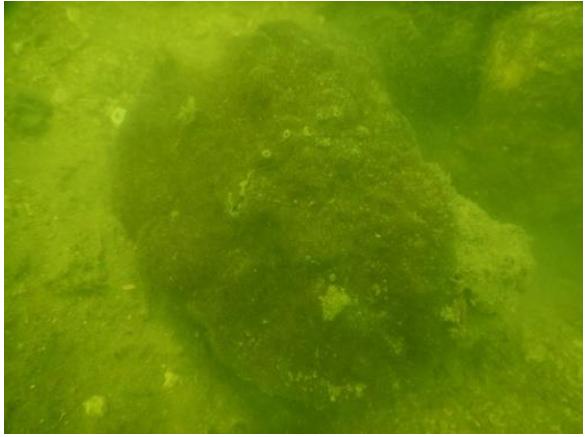
A photograph showing a circular tag with the number '10' on a dark, textured surface. The tag is white with black numbers.

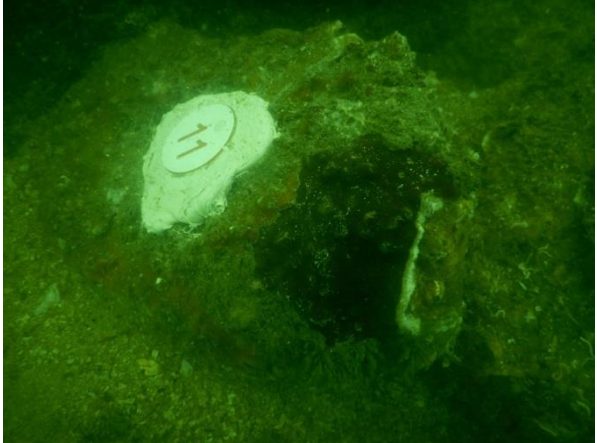
Tag #	Baseline	26-June	20-September
11

A close-up photograph of a white circular tag with the number '11' on it, attached to a dark, textured surface. The tag is slightly tilted and has some white residue around it.

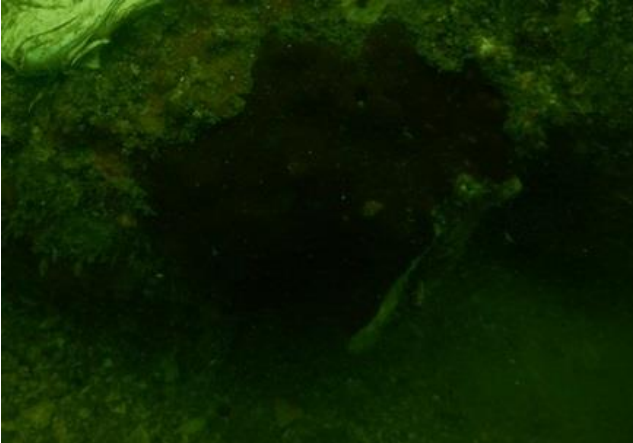
A dark, low-contrast photograph of the same tag area, showing significant shadowing and loss of detail compared to the baseline image.	Missing
12

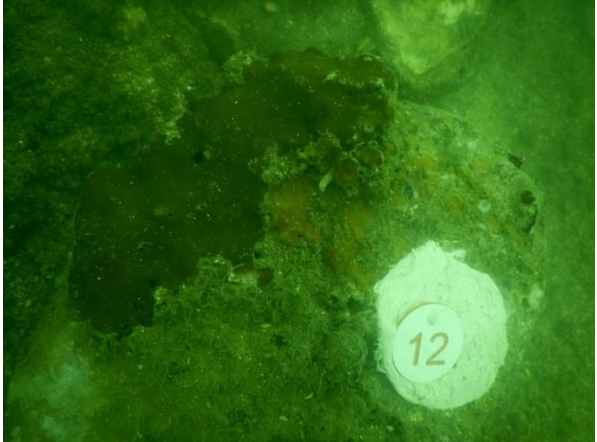
A close-up photograph of a white circular tag with the number '12' on it, attached to a dark, textured surface. The tag is slightly tilted and has some white residue around it.

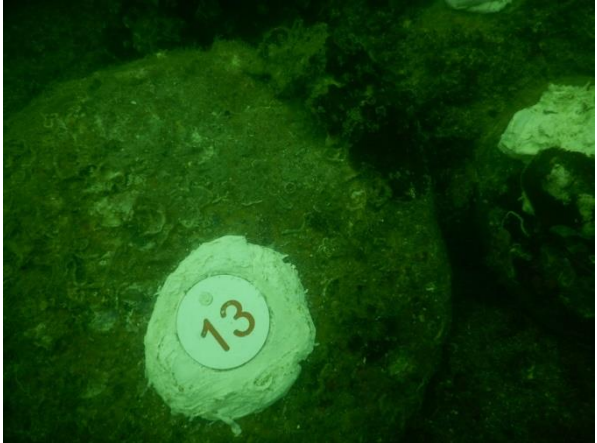
Tag #	Baseline	26-June	20-September
13

A close-up photograph of a circular white tag with the number '13' printed in black. The tag is attached to a dark, textured surface, possibly a rock or piece of coral, which is covered in green algae or other marine growth.

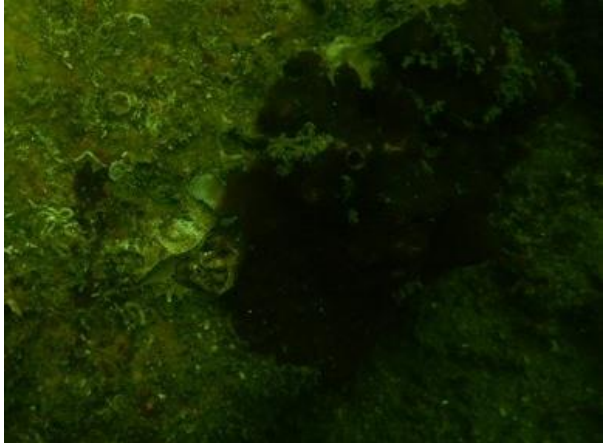
A photograph showing the same area as the baseline image, but the tag is no longer visible. The dark, textured surface is still present, covered in green algae.	Missing
14

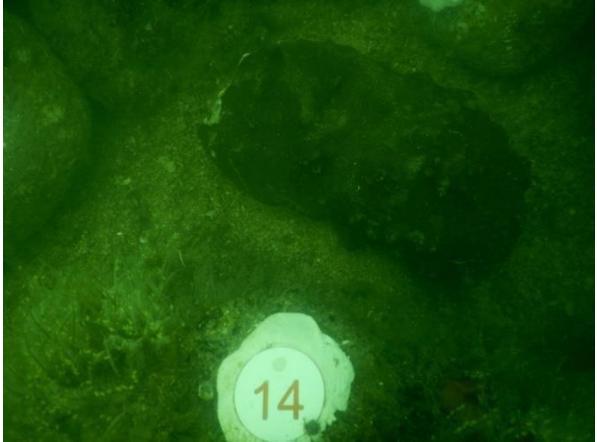
A close-up photograph of a circular white tag with the number '14' printed in black. The tag is attached to a dark, textured surface, possibly a rock or piece of coral, which is covered in green algae or other marine growth.

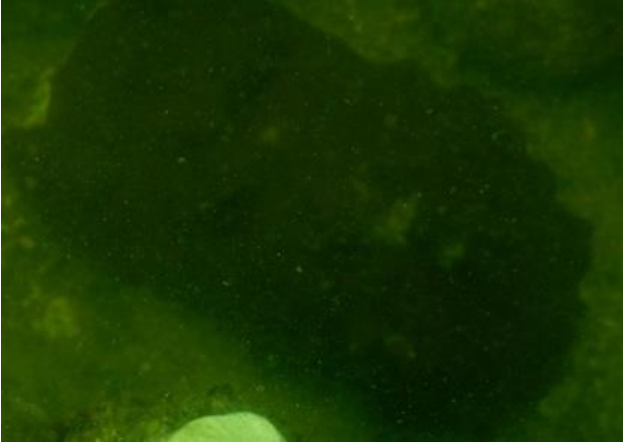
A photograph showing the same area as the baseline image, but the tag is no longer visible. The dark, textured surface is still present, covered in green algae.	Missing

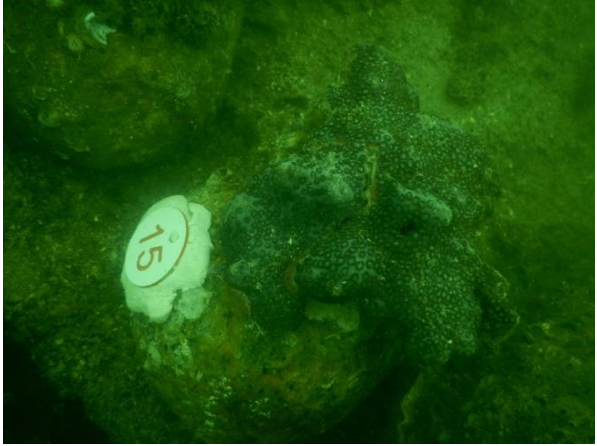
Tag #	Baseline	26-June	20-September
15

A photograph of a rock covered in green algae. A white circular tag with the number '15' is attached to the rock.

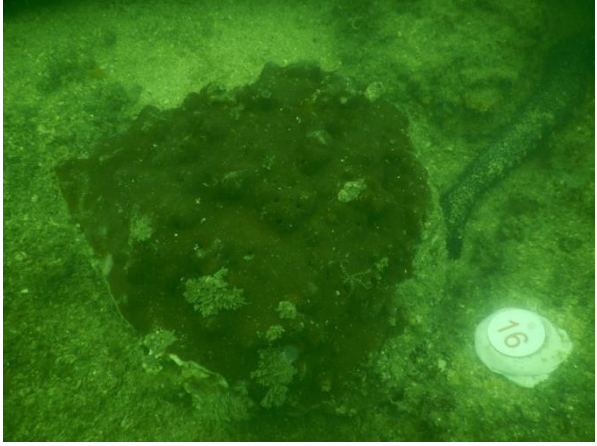
A photograph of a rock covered in green algae. A white circular tag with the number '16' is attached to the rock.

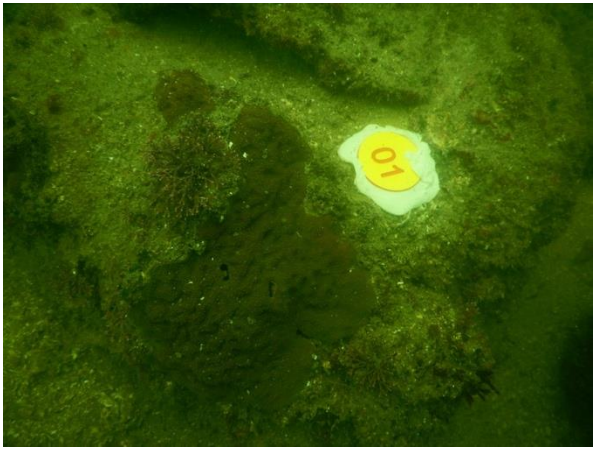
Tag#	Baseline	26-June	20-September
1

A photograph showing a yellow circular tag with the number '01' on a dark, textured coral surface. The tag is slightly irregular in shape and is surrounded by the coral's natural growth.

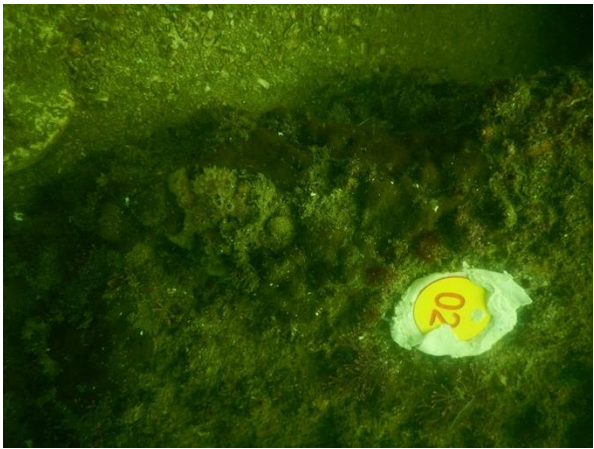
A photograph showing a yellow circular tag with the number '02' on a dark, textured coral surface. The tag is slightly irregular in shape and is surrounded by the coral's natural growth.

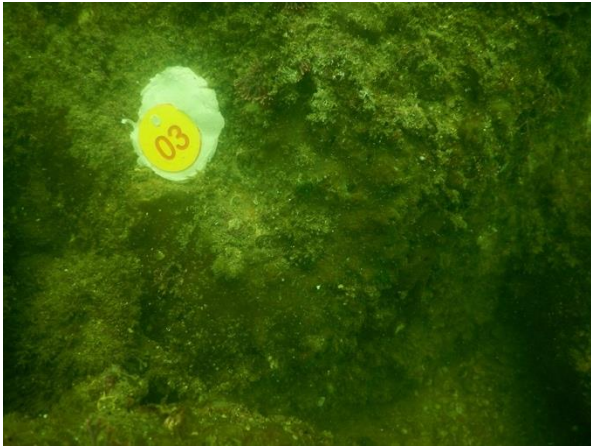
Tag#	Baseline	26-June	20-September
3

Underwater photograph of Tag 03 at the Baseline site. The tag is a white circular marker with the number '03' in yellow, resting on a green, algae-covered substrate.

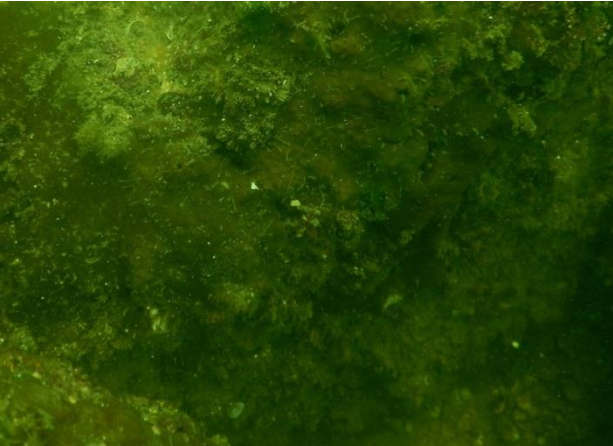
Underwater photograph of Tag 03 at the 26-June site. The tag is not clearly visible, but the surrounding green algae cover is dense.

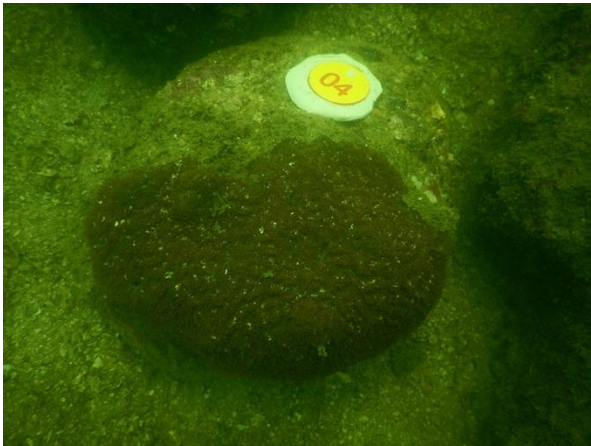
Underwater photograph of Tag 04 at the Baseline site. The tag is a white circular marker with the number '04' in yellow, positioned next to a large, dark, circular object on a green, algae-covered substrate.

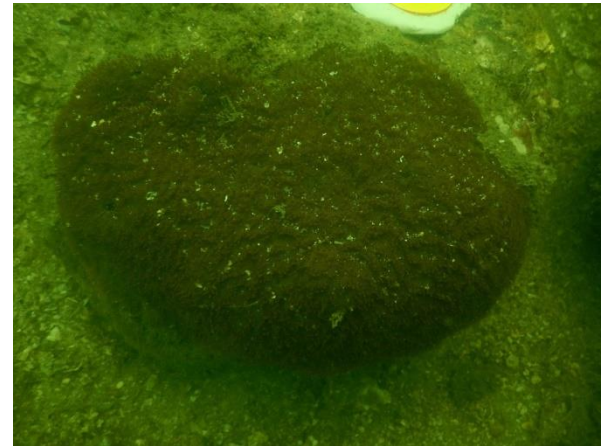
Underwater photograph of Tag 04 at the 26-June site. The tag is partially visible at the top edge, and the dark circular object is prominent on the green substrate.

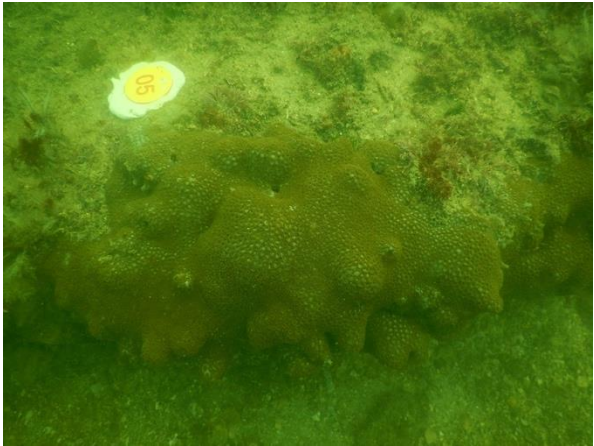
Tag#	Baseline	26-June	20-September
5

A photograph showing a yellow tag with the number '5' on a green, textured surface. The tag is partially covered by a white protective cap.		
6

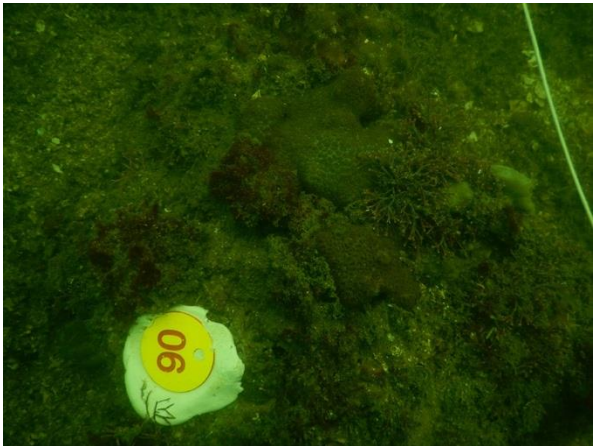
A photograph showing a yellow tag with the number '90' on a green, textured surface. The tag is partially covered by a white protective cap.

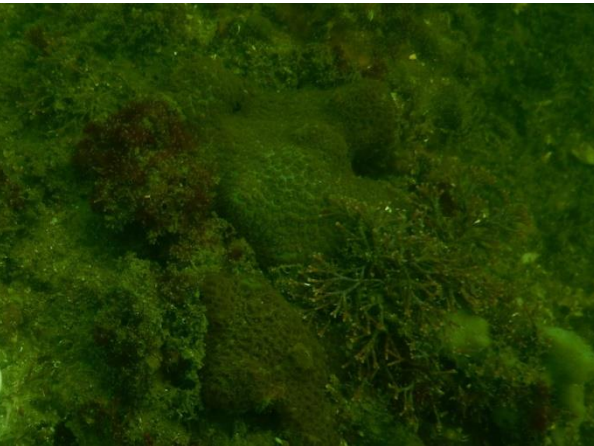
A photograph showing a green, textured surface, likely the same area as the baseline photo for Tag 90, but without the tag visible.

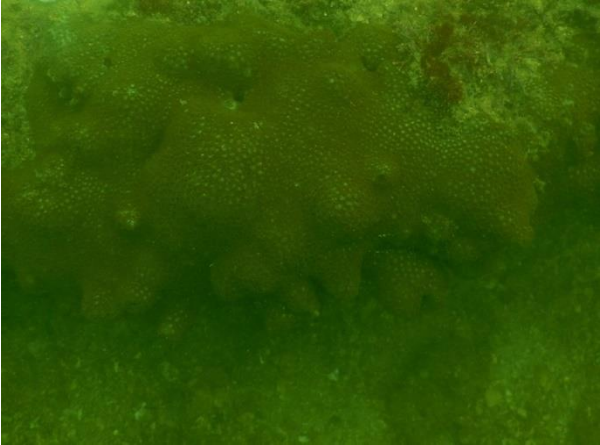
A photograph of the same object as in the baseline image, showing a similar appearance with the yellow tag '07' still visible.

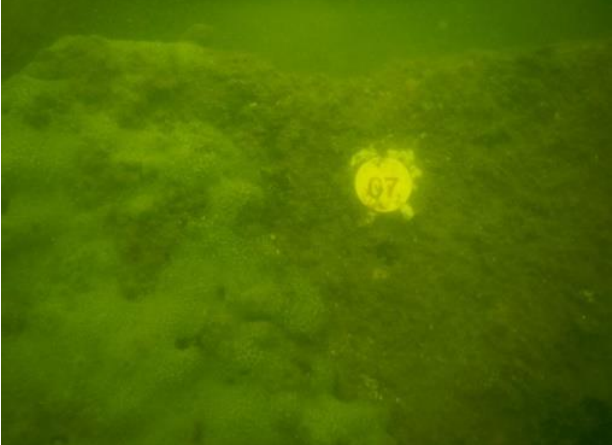
A photograph of the same object, showing a significant increase in its size and a more textured, porous appearance. The yellow tag '07' is still present.
8

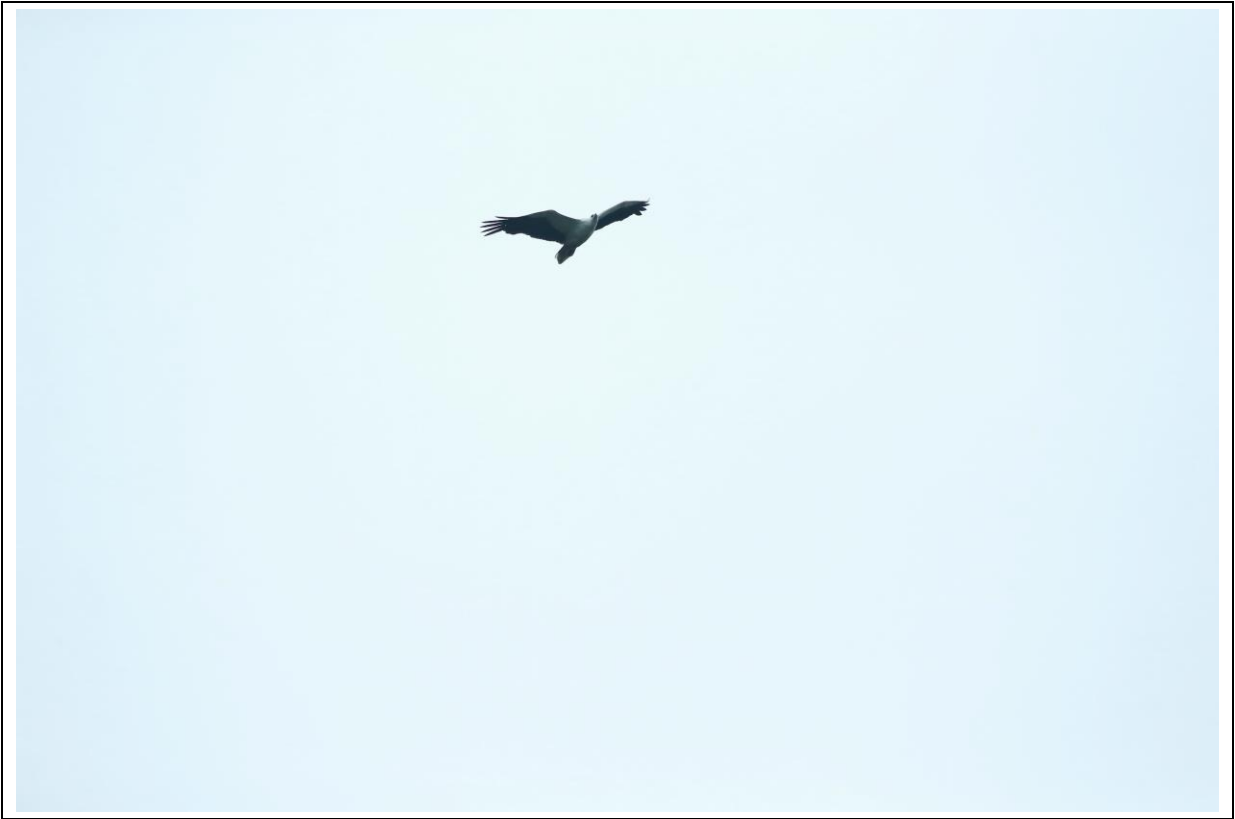
Photo Plate for 1st Monthly WBSE monitoring

Adult WBSE was flying in the sky

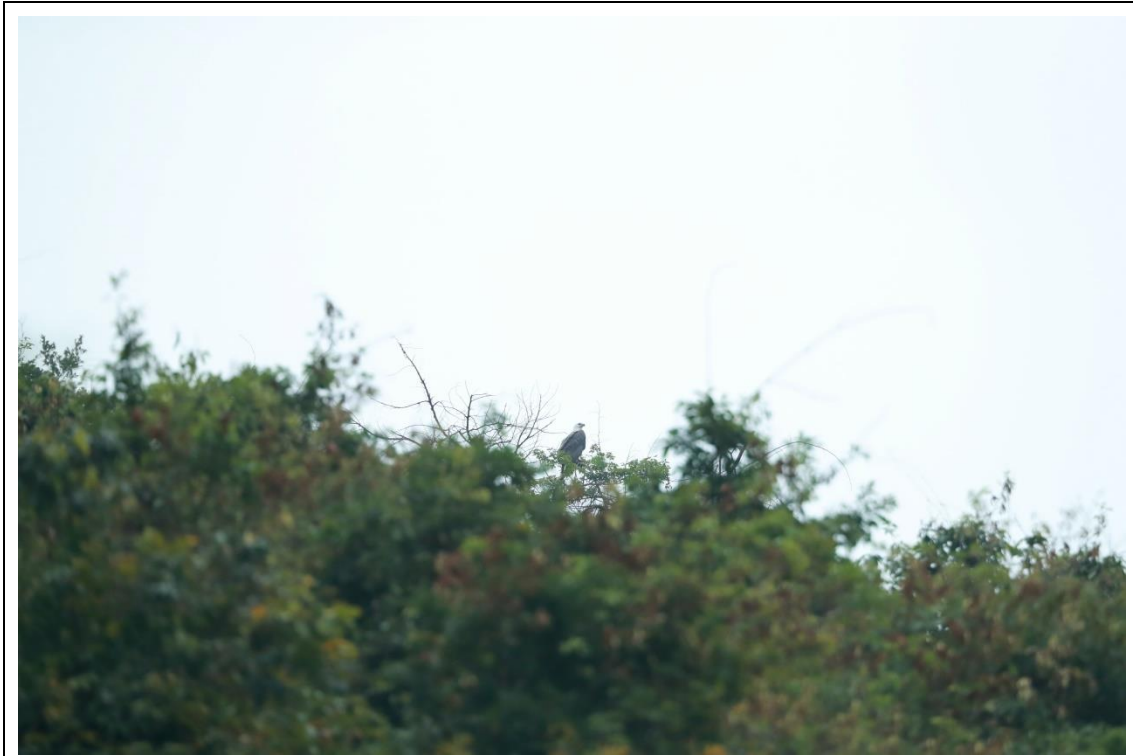
Photo Plate for 2nd Monthly WBSE monitoring

Adult WBSE Stayed on the Tree Top

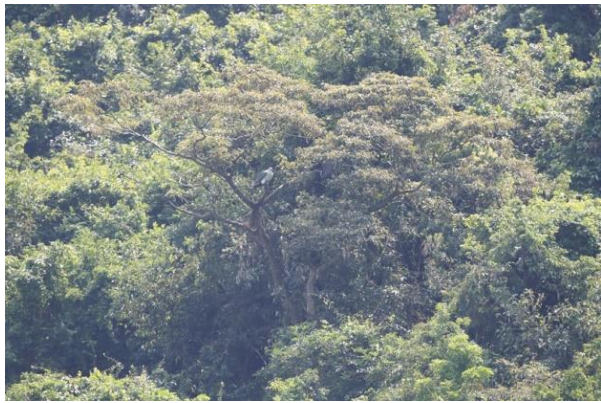
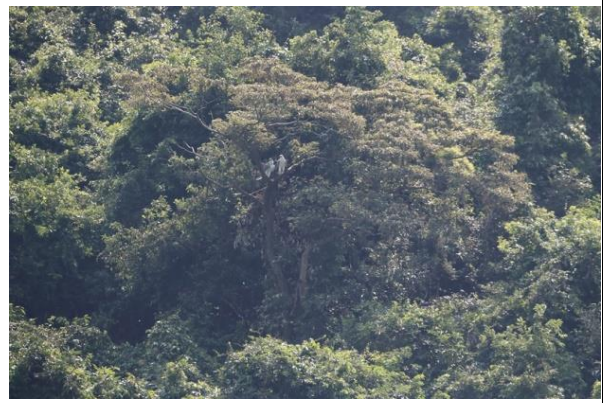
Photo Plate for 3rd Monthly WBSE monitoring

Adult WBSEs Stayed on the Same Tree of the Original Nest

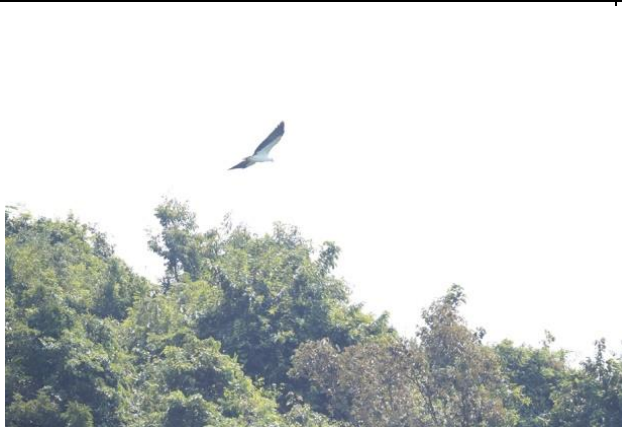
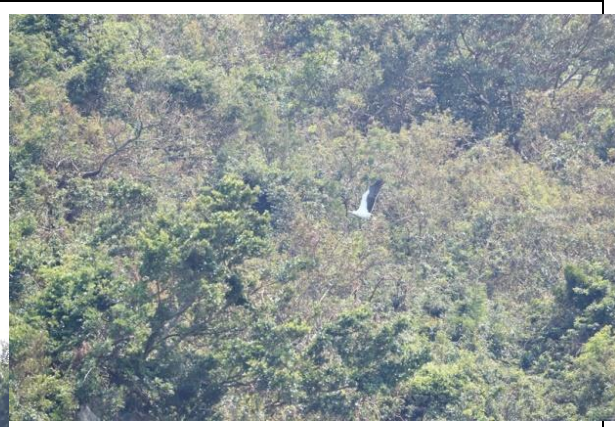
Adult WBSEs Flying Over at SKC to Bring Tree Branches to Rebuild the Nest
