Contract No. EP/SP/66/12
Integrated Waste Management Facilities, Phase 1
Monthly EM&A Report No.5

Monthly EM&A Report No.5 (Period from 1 November to 30 November 2018)

(Clause 3.3, Further Environmental Permit FEP-01/429/2012/A)

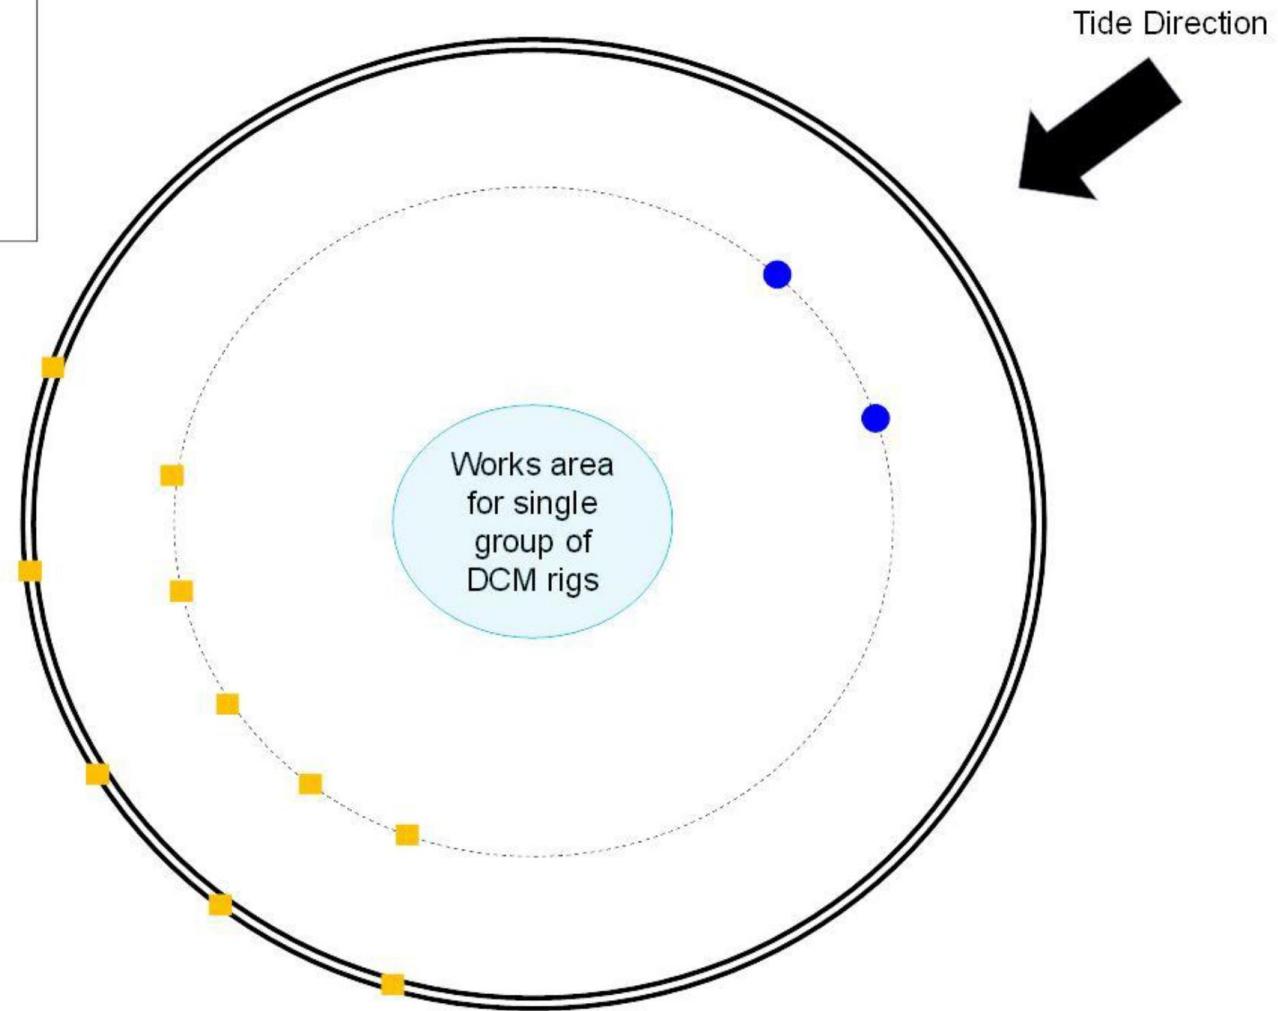
Figure 2.2 Water monitoring locations during intensive DCM monitoring

- Two monitoring stations upstream and at 150 m envelope of DCM group works area (Representative Control stations).
- Five monitoring stations downstream and at 150 m envelope of DCM group works area (Impact 1 stations).
- Five monitoring stations downstream and at 250 m envelope of DCM group works area (Impact 2 stations).
- Monitoring stations should be at least 50 m apart;
- Downstream monitoring stations should be perpendicular to the tidal direction.

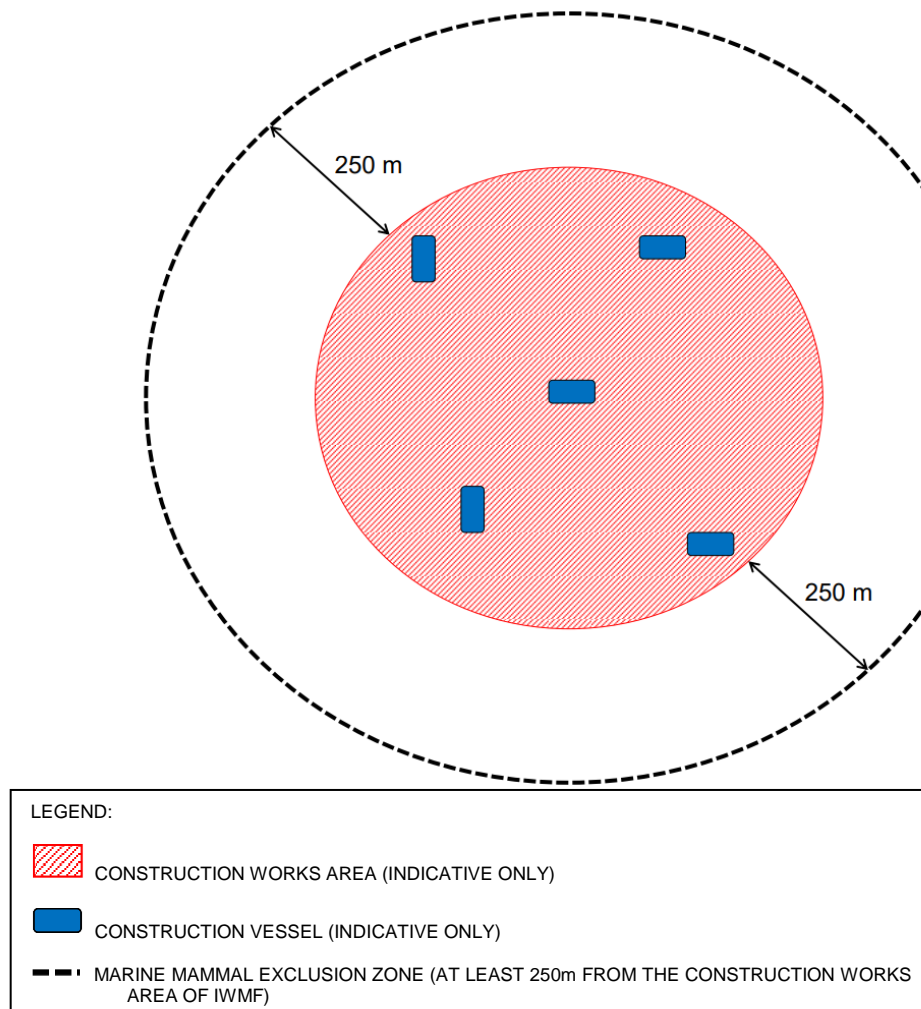
Figure 6.4 Illustration of Typical MMEZ

A MMEZ with 250 m distance from the boundary of a work area shall be established during the above situation. A typical MMEZ is indicated in **Figure 6.4** for reference. The MMEZ serves as a monitoring approach to provide appropriate and immediate actions once finless porpoise or Chinese White Dolphin is sighted within the MMEZ. All MMEZ will be monitored by competent Marine Mammal Observers (MMOs) to be provided by the Environmental Team (ET) for the IWMF and trained by the Marine Mammal Monitoring Specialist of the ET who is independent from JV.
