Contract No. EP/SP/66/12  
Integrated Waste Management Facilities, Phase 1  
Monthly EM&A Report No.6

## Monthly EM&A Report No.6 (Period from 1 December to 31 December 2018)

(Clause 3.3, Further Environmental Permit FEP-01/429/2012/A)

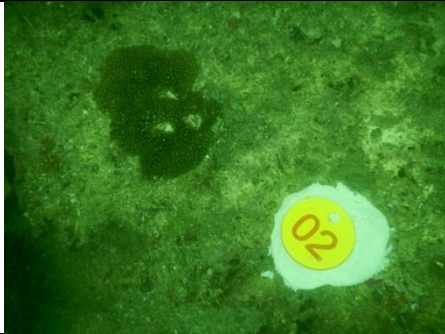
Tag #	3 December 2018	
#2R

Tag #	Species	Size (cm) – Max. Diameter	Condition	Mortality (%)	Bleaching (%)	Sediment (%)
2R	<i>Goniopora stutchburyi</i>	10	Good	0	0	0
5R	<i>Goniopora stutchburyi</i>	18	Good	0	0	0
7R	<i>Coscinaraea</i> sp.	15	Good	0	0	0
10R	<i>Goniopora stutchburyi</i>	20	Good	0	0	0

**Photo Plate 5.1 Re-tagged Corals at Control Site**

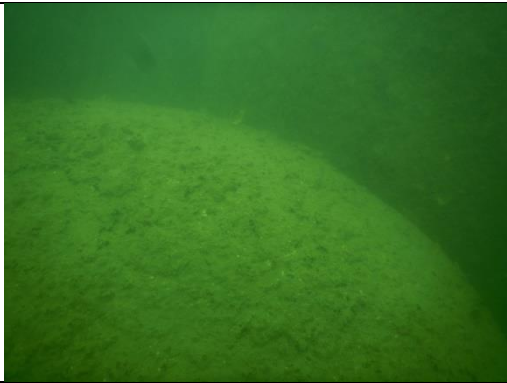
**Photo Plate 5.4 Representative photo records during the REA survey**

5.6.4 The REA surveys were performed on 3 December 2018 at Indirect Impact Site and the weather condition was summarized in **Table 5.10**.

<b>Big Boulders</b>

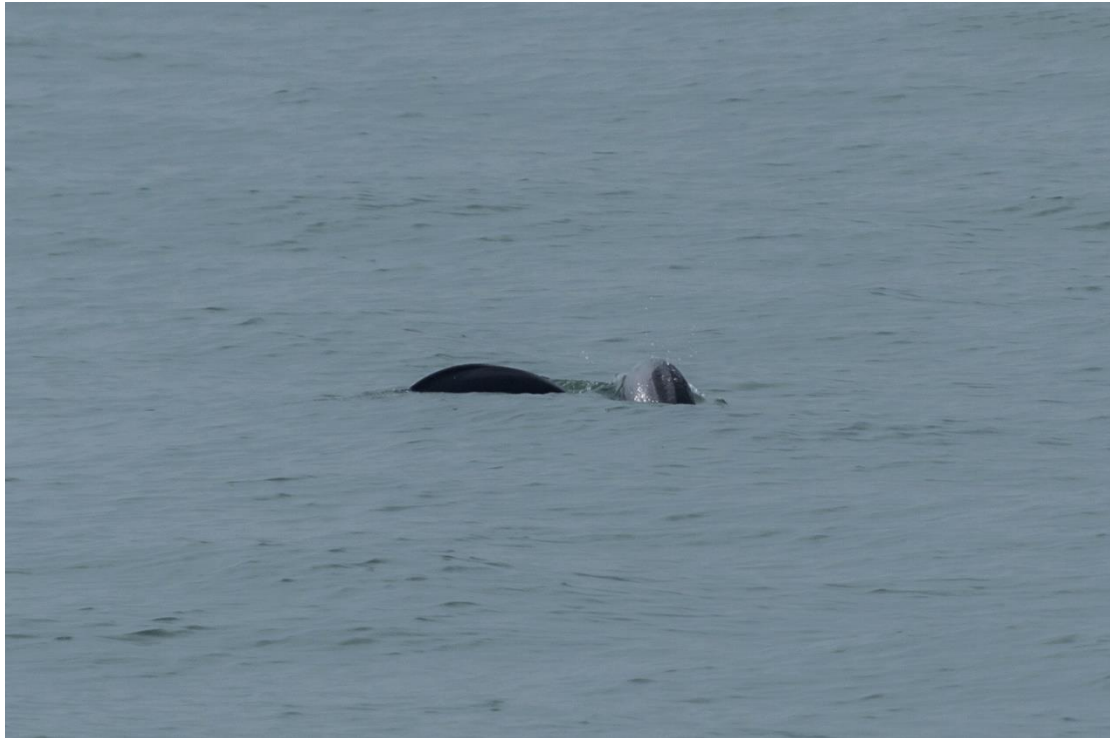
**Figure 6.5 Location of sightings recorded during December 2018 Vessel-based Line-transect Survey**

The monthly survey was conducted on 6 and 20 December 2018. As this is the designated peak season (December - May), two surveys were completed. A total on effort (transects only) survey length of 79.5 km was completed, 78.6 km at Beaufort Sea State 2 or better (**Table 6.4**). Five finless porpoise sightings were recorded, three (3) “on effort” and two (2) while transiting between transect lines (referred to as secondary line in AFCD reports (**Table 6.5, Figure 6.5**)).

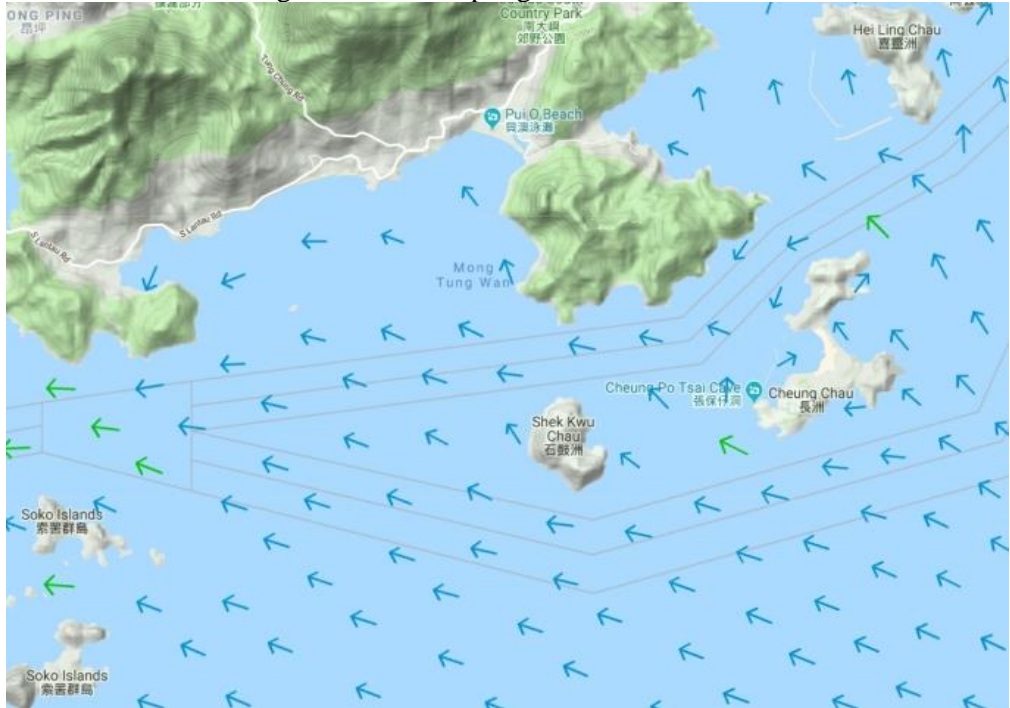
<p>Dominating sea current direction was found to be from Southeast to Northwest at waters around Shek Kwu Chau.</p> <p>M1 is located at unrelated stream direction (neither upstream nor downstream, far away) to the works location, exceedance of this monitoring location is deemed to be unrelated to the Project.</p> <p>Silt curtain checking was implemented by contractor and checking result showed no deficiency of silt curtain was found.</p> <p>Site tidiness in the present barges in the Project site were checked during weekly site inspection on 4/12, where sand on the pontoon surface was nearly overflowed to the sea on FTB 19 and a big lump of sand was observed at the edge of the barge surface on 祥記 7. However, according to the rationale in the previous paragraph, these two observations were not considered as the source of SS exceedance.</p>
<p>Actions taken / to be taken</p>	<p>The Contractor was reminded to clean up the sand more frequently and hence to avoid the sand was leaked outside the silt curtain. The Contractor was reminded to use an elongated soft hose to avoid the sand accumulation on the pontoon surface during sand blanket laying process.</p> <p>Examination of environmental performance of the Project will be continued during the weekly inspection, and the Contractor is reminded to implement all applicable mitigation measures as per the Updated EM&amp;A Manual.</p>

<p>Remarks</p>	<p>Current direction during mid-flood sampling on 5/12:</p>

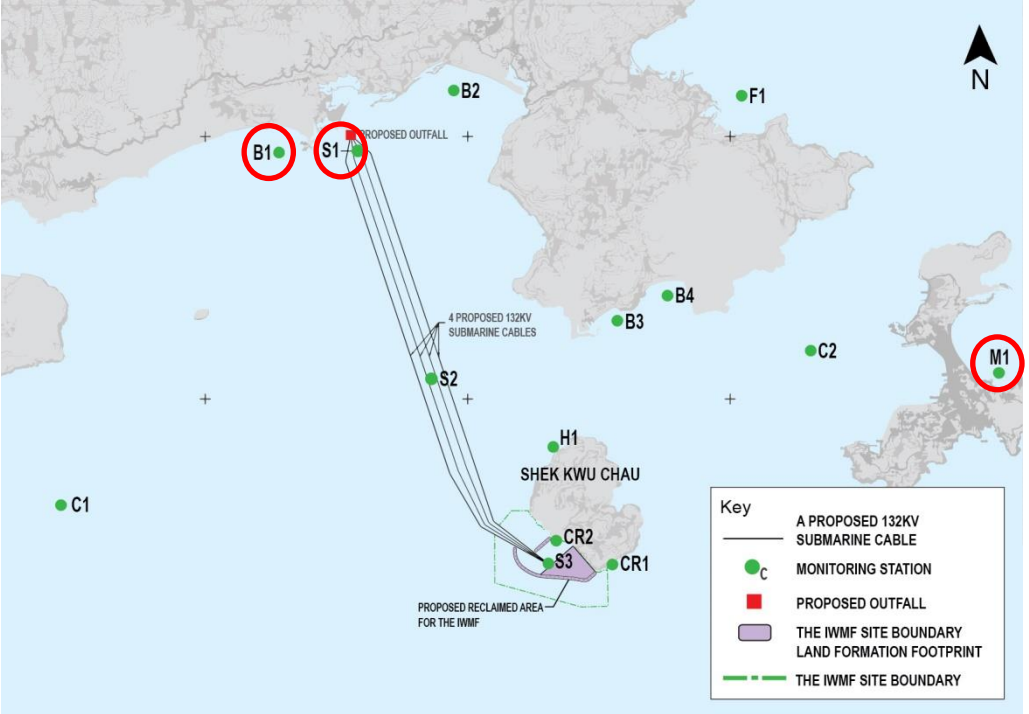
<p>The map shows the project site layout with various monitoring stations marked with green dots. Stations B1, M1, and S1 are circled in red. A proposed outfall is also circled in red. The map includes labels for 'PROPOSED OUTFALL', '4 PROPOSED 132KV SUBMARINE CABLES', 'PROPOSED RECLAIMED AREA FOR THE IWMF', and 'SHEK KWU CHAU'. A key in the bottom right corner defines the symbols: a green dot for 'MONITORING STATION', a red square for 'PROPOSED OUTFALL', a purple outline for 'THE IWMF SITE BOUNDARY', a grey outline for 'LAND FORMATION FOOTPRINT', and a green dashed line for 'THE IWMF SITE BOUNDARY'. A north arrow is located in the top right corner.</p>		
<p>Parameter</p>	<p>Suspended Solid (SS)</p>		
<p>Action &amp; Limit Levels</p>	<p>Action Level</p>		<p>Limit Level</p>
	<p>≥ 15.0 mg/L (120% of C1)</p>		<p>≥ 16.3 mg/L (130% of C1)</p>

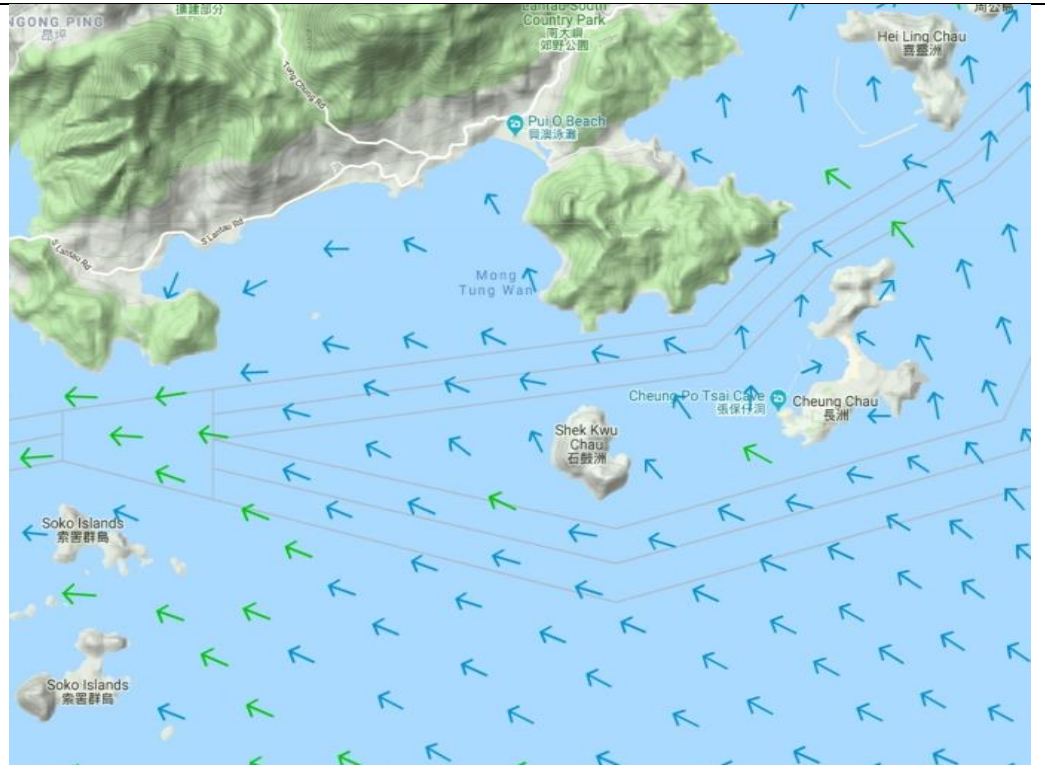
<p>Parameter</p>	<p>Suspended Solid (SS)</p>		
<p>Action &amp; Limit Levels</p>	<p>Action Level</p>		<p>Limit Level</p>
	<p>≥ 8.0 mg/L</p>		<p>≥ 10.0 mg/L</p>
<p>Measurement Level</p>	<p>Impact Station(s) of Exceedance</p>	<p>Control Stations</p>	<p>Impact Station(s) without Exceedance</p>
	<p>8.5 mg/L (CR1) 9.8 mg/L (S1)</p>	<p>5.5 mg/L (C1) 6.7 mg/L (C2)</p>	<p>7.3 mg/L (B1) 7.8 mg/L (B2) 7.8 mg/L (B3) 5.8 mg/L (B4) 5.8 mg/L (F1) 6.3 mg/L (H1) 5.3 mg/L (M1) 7.8 mg/L (CR2) 7.5 mg/L (S2) 7.7 mg/L (S3)</p>
<p>Possible reason for Action or Limit Level Non-compliance</p>	<p>From MMO monitoring records on 27/12, two DCM barges (ESC-61 &amp; ESC-62) and two dumb lighters (DT 12 &amp; FTB 19) were in operations on that day. No deficiency of silt curtain was found before the start of construction activity.</p> <p>Silt curtain checking was implemented by the Contractor and checking results showed no deficiency of silt curtain was found on that day.</p> <p>Site tidiness in the present barges in the Project site were checked during weekly site inspection on 27/12, where was no major observation of improper site practice that might contribute to the increase in SS level was observed during the inspection.</p>

<p>Actions taken / to be taken</p>	<p>Asking the Contractor to provide more information.</p>		
<p>Remarks</p>	<p>Current direction during mid-flood sampling on 27/12:</p>

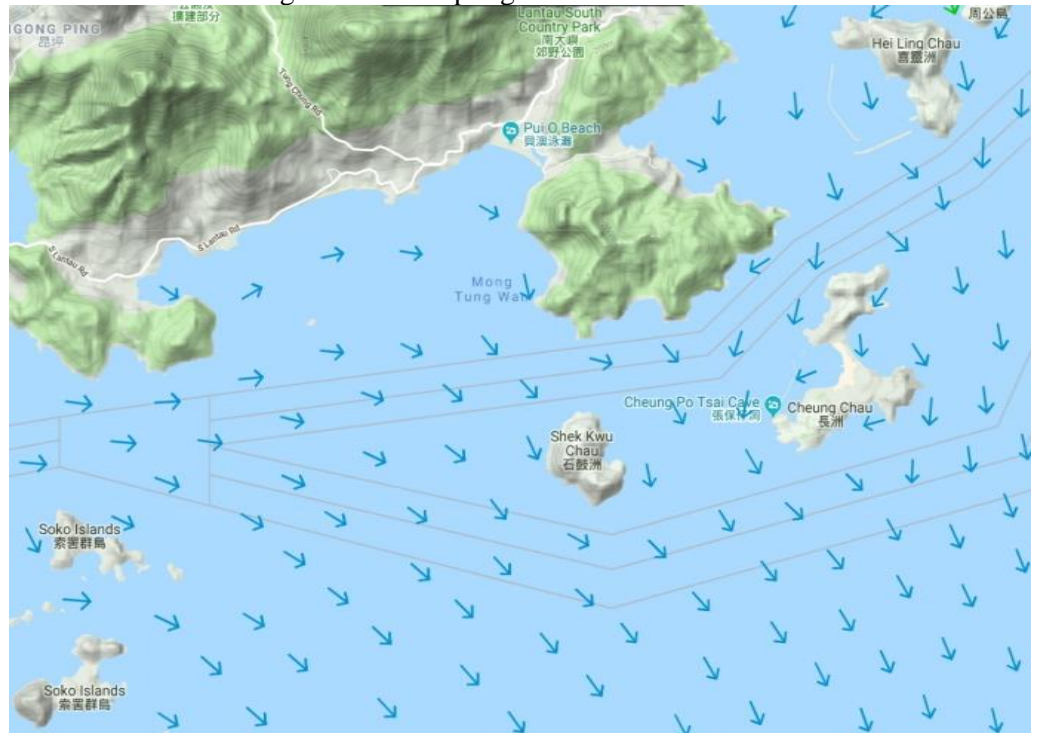
Current direction during mid-ebb sampling on 27/12:
