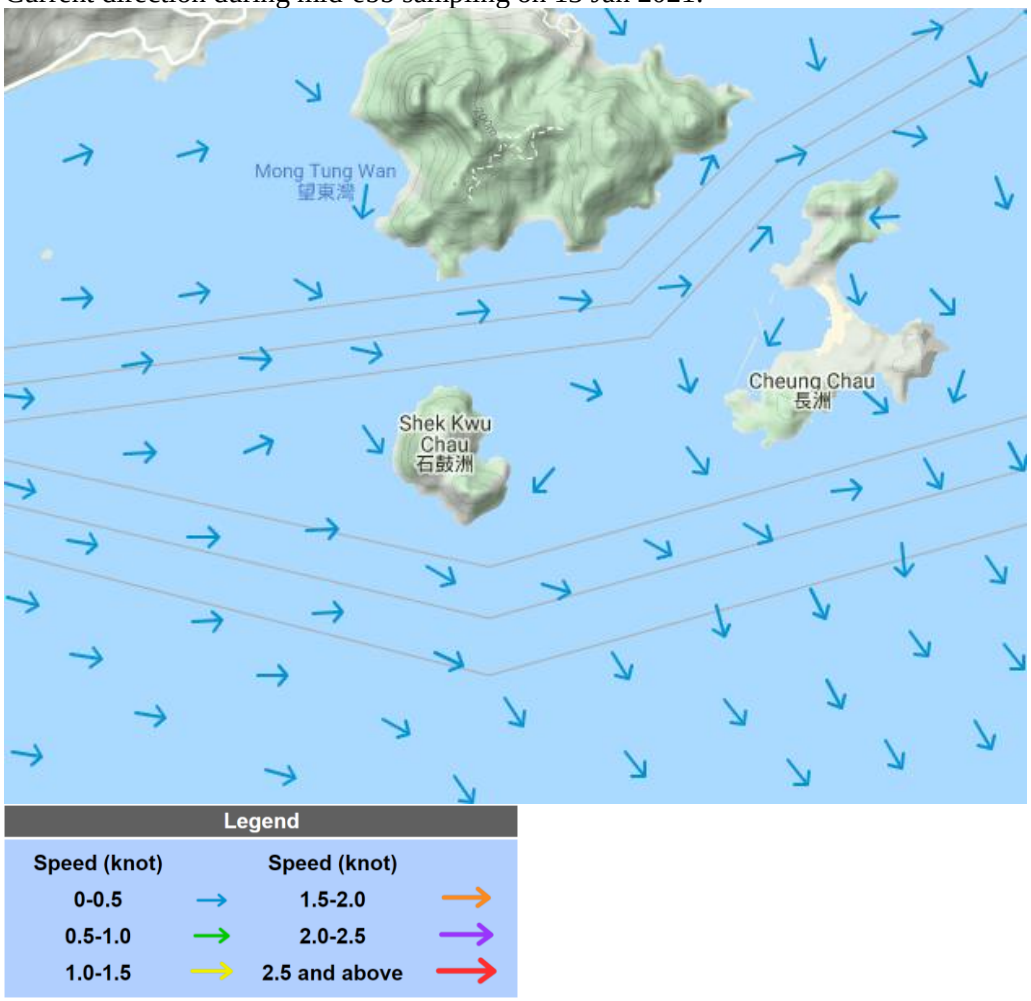
Incident Report on Action Level or Limit Level Non-compliance

Project	Integrated Waste Management Facilities, Phase 1		
Date	13 Jan 2021 (Lab result received on 18 Jan 2021)		
Time	11:02 – 14:32 (Mid-Ebb)		
Mid-Ebb			
Monitoring Location	B2 		
Parameter	Suspended Solid (SS)		
Action & Limit Levels	Action Level	Limit Level	
	≥ 8.0 mg/L	≥ 10.0 mg/L	
Measurement Level	Impact Station(s) of Exceedance	Control Stations	Impact Station(s) without Exceedance

8.0 mg/L (B2)	6.3 mg/L (C1A) 5.8 mg/L (C2A)	6.5 mg/L (B1) 7.5 mg/L (B3) 7.0 mg/L (B4) 6.3 mg/L (F1A) 5.7 mg/L (H1) 4.8 mg/L (M1) 5.7 mg/L (CR1) 6.7 mg/L (CR2)
Possible reason for Action or Limit Level Non-compliance	Works scheduled on site on 13 Jan 2021 include reclamation works, laying of rockfill and caisson installation. Dominating sea current direction was found to be from Northwest to Southeast at waters around Shek Kwu Chau. B2 is located at unrelated stream direction (neither upstream nor downstream, far away) to the works location, exceedance of this monitoring station is deemed to be unrelated to the Project. Silt curtain checking by the Contractor was implemented on Marine Access (13 Jan 2021, 10:30am) and checking results showed that no deficiency of silt curtain was found on that day.

From MMO monitoring records on 13 Jan 2021, MMO team was arranged for one derrick barge (金盈 8)) and silt curtain at western marine access area on that day while no deficiency of silt curtain was found before the commencement of and during construction activity. According to the field observation by Marine Mammal Observer team & sampling team during sampling event, no silt plume was observed in the Project site. Site tidiness in the present barges in the Project site were checked during weekly site inspection on 12 Jan 2021. No major observation of improper site practices that could contribute to the increase of the suspended solids recorded.
Remarks	Current direction during mid-ebb sampling on 13 Jan 2021:  (Sourced from http://current.hydro.gov.hk/en/map.html)
Prepared by	Joe Ho
Date	1 Feb 2021

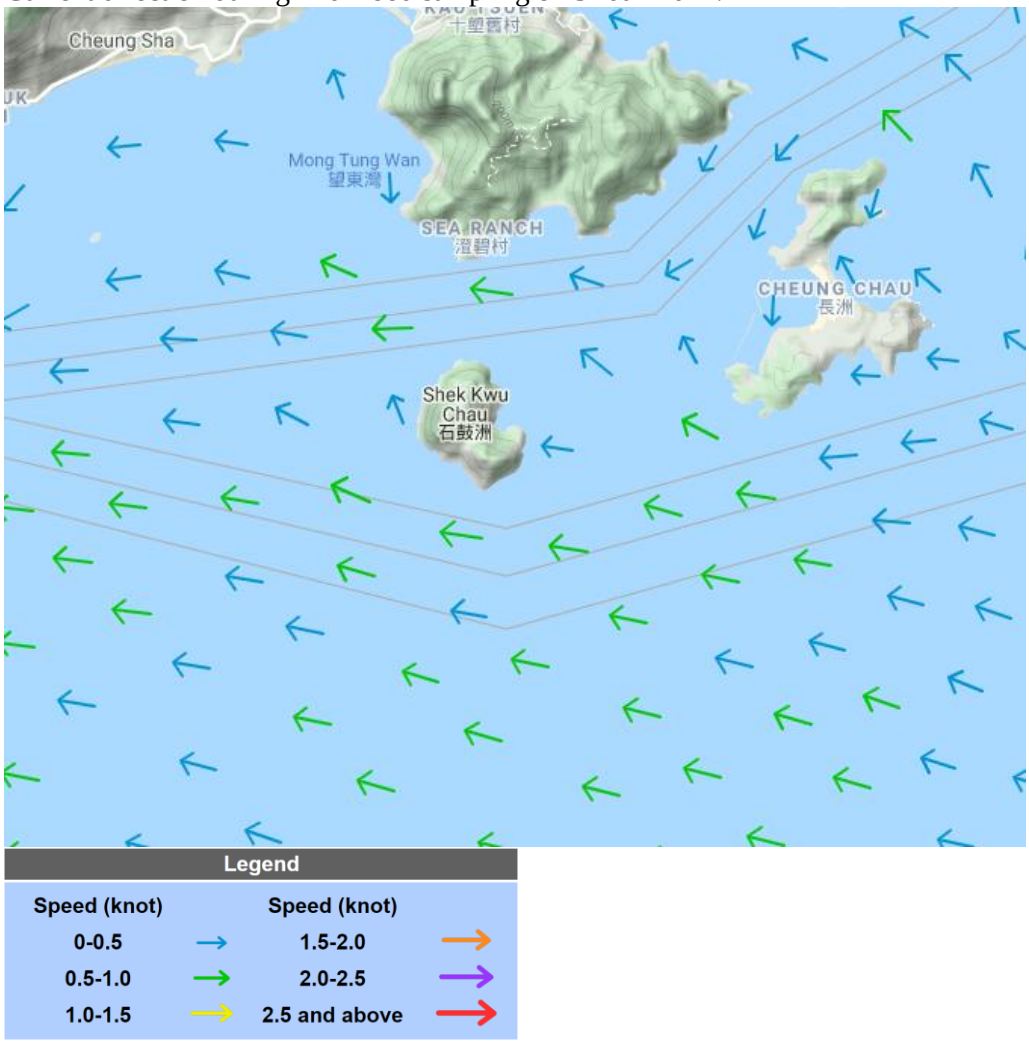
Incident Report on Action Level or Limit Level Non-compliance

Project	Integrated Waste Management Facilities, Phase 1		
Date	31 Jan 2020 (Lab result received on 3 Feb 2021)		
Time	08:00 – 11:30 (Mid-Flood)		
Mid-Flood			
Monitoring Location	B1, B4, M1  		
Parameter	Suspended Solid (SS)		
Action & Limit Levels	Action Level	Limit Level	
	≥ 9.0 mg/L (120% of C2A)	≥ 10.0 mg/L	
Measurement Level	Impact Station(s) of Exceedance	Control Stations	Impact Station(s) without Exceedance

9.0 mg/L (B1) 11.5 mg/L (B4) 9.7 mg/L (M1)	7.7 mg/L (C1A) 7.5 mg/L (C2A)	8.0 mg/L (B2) 8.5 mg/L (B3) 8.2 mg/L (F1A) 8.3 mg/L (H1) 6.8 mg/L (CR1) 6.3 mg/L (CR2)
Possible reason for Action or Limit Level Non-compliance	Works scheduled on site on 31 Jan 2021 include reclamation works, laying of rockfill and caisson installation. Dominating sea current direction was found to be from Southeast to Northwest at waters around Shek Kwu Chau. B1, B4 and M1 are located at unrelated stream direction (neither upstream nor downstream, far away) to the works location, exceedance of this monitoring station is deemed to be unrelated to the Project. Silt curtain checking by the Contractor was implemented on Marine Access (31 Jan 2021, 07:00am) and checking results showed that no deficiency of silt curtain was found on that day. From MMO monitoring records on 31 Jan 2021, MMO team was arranged for one derrick barge (金盈 8)) and silt curtain at western marine access area on that day while

no deficiency of silt curtain was found before the commencement of and during construction activity. According to the field observation by Marine Mammal Observer team & sampling team during sampling event, no silt plume was observed in the Project site. Site tidiness in the present barges in the Project site were checked during weekly site inspection on 27 Jan 2021. No major observation of improper site practices that could contribute to the increase of the suspended solids recorded.
Remarks	Current direction during mid-flood sampling on 31 Jan 2021:  (Sourced from http://current.hydro.gov.hk/en/map.html)
Prepared by	Joe Ho
Date	4 Feb 2021
