Appendix N Exceedance Report

Statistical Summary of Exceedances in the Reporting Period

Project	Integrated Waste Management Facilities, Phase 1		
Date	2 Feb 2021 (Lab result received on 5 Feb 2021)		
Time	14:12 – 17:42 (Mid-Ebb) 08:15 – 11:45 (Mid Flood)		
Mid-Ebb			
Monitoring Location	B2, F1A, H1, CR2

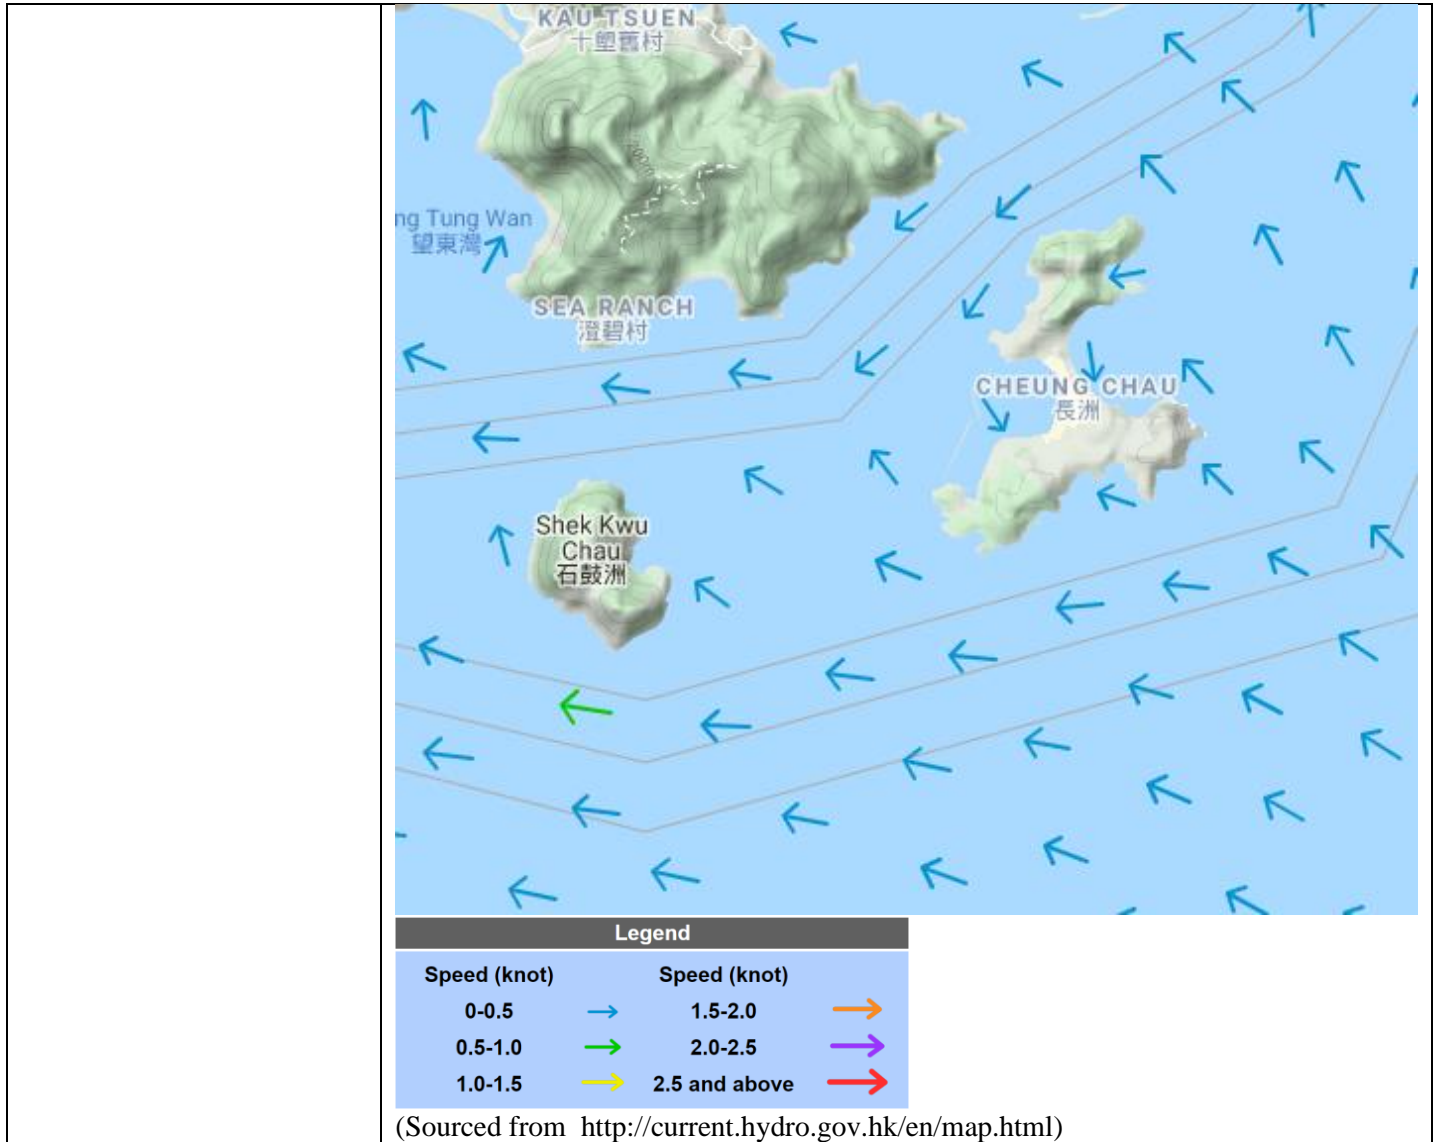
<p>Current direction during mid-flood sampling on 2 Feb 2021:</p>

Dominating sea current direction was found to be from Southeast to Northwest at waters around Shek Kwu Chau.
