Contract No. EP/SP/66/12
Integrated Waste Management Facilities, Phase 1
Monthly EM&A Report No.15

Monthly EM&A Report No.15 (Period from 1 September to 30 September 2019)

(Clause 3.3, Further Environmental Permit FEP-01/429/2012/A)

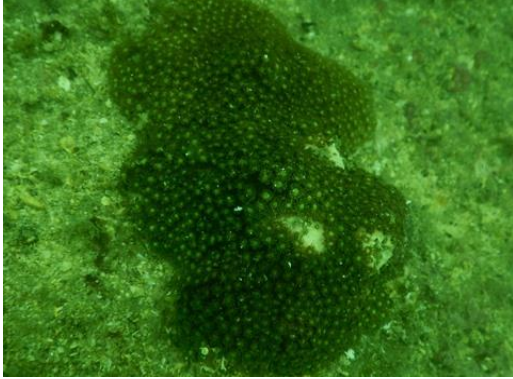
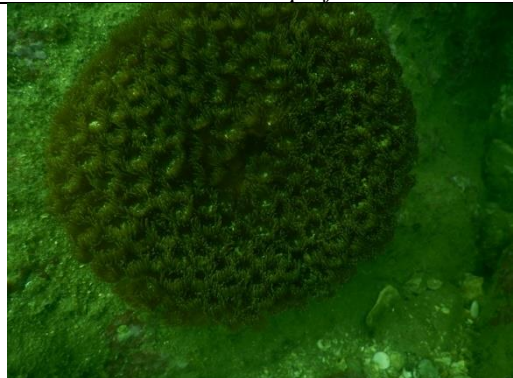
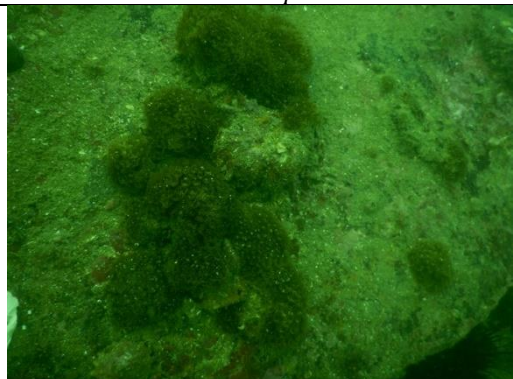
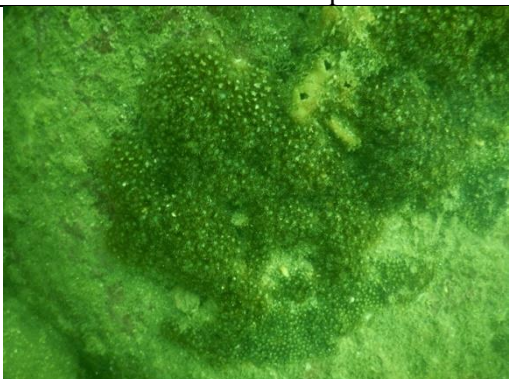
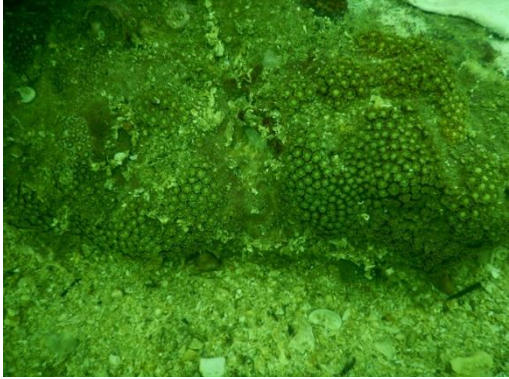
Tag #	18 September 2019
#1

5.6.2 Ten (10) hard coral colonies were monitored at each Control site and Indirect Impact Site as suggested in the Construction Phase Monitoring Plan. The general health conditions (size, mortality, bleaching and sediment) were recorded and summarized in **Table 5.8** and **Table 5.9**. Photos of each coral colonies were taken during the monitoring activities shown in **Photo Plate 5.1** and **5.2**.

- 5.6.5 All tagged and re-tagged coral colonies showed good health condition during the 3rd Quarterly Construction Phase Monitoring. There was no increased level of mortality, bleaching and sediment when compared with the baseline results.

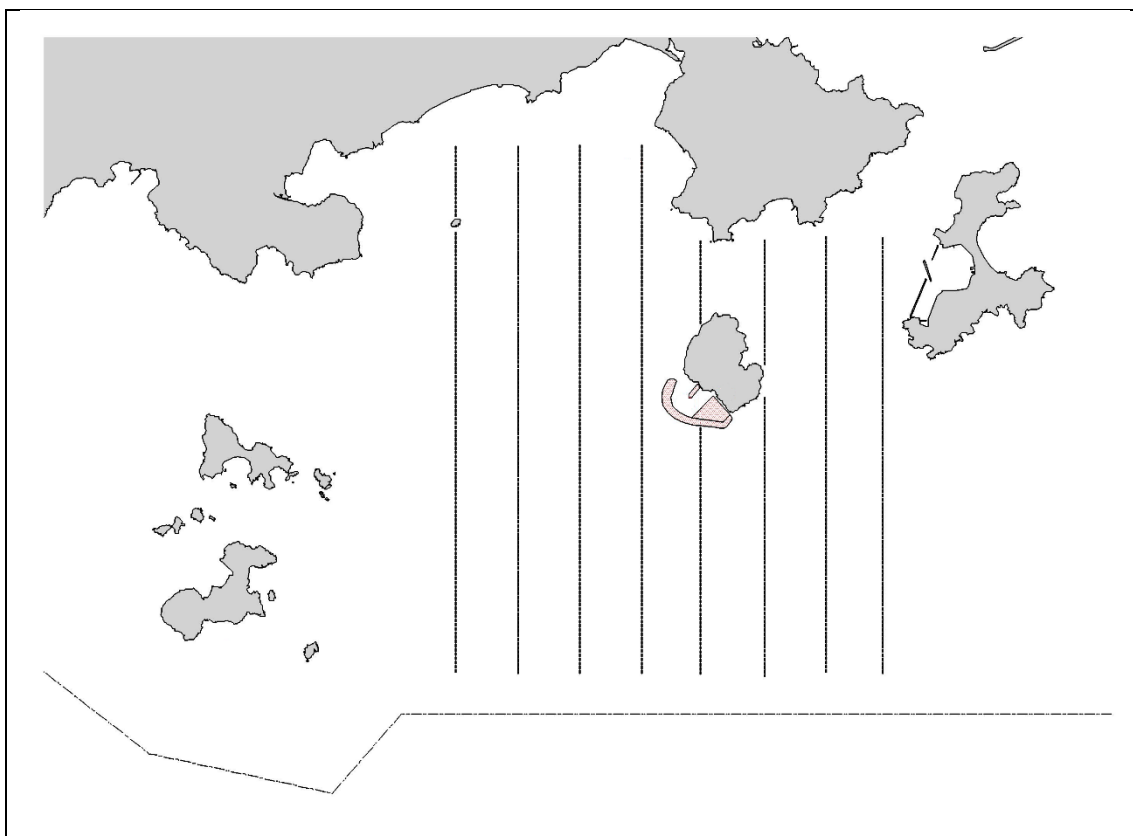
Figure 6.1 Line Transects for Marine Mammal Surveys

6.2.1.2 Eight transect lines are set at Southeast Lantau survey area, including Shek Kwu Chau, waters between Shek Kwu Chau and the Soko Islands, inshore waters of Lantau Island (e.g. Pui O Wan) as well as southwest corner of Cheung Chau as shown in **Figure 6.1** below:

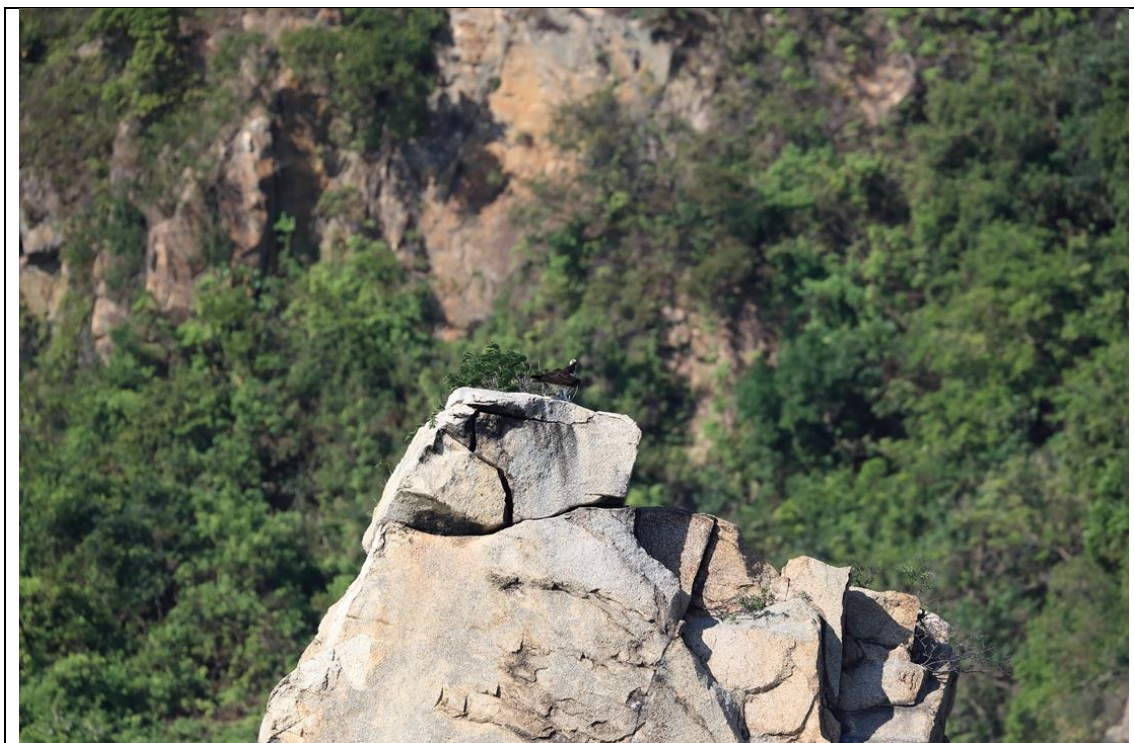
Figure 7.2 Photo Record of WBSE on SKC During the Reporting Period

Adult WBSE recorded in SKC

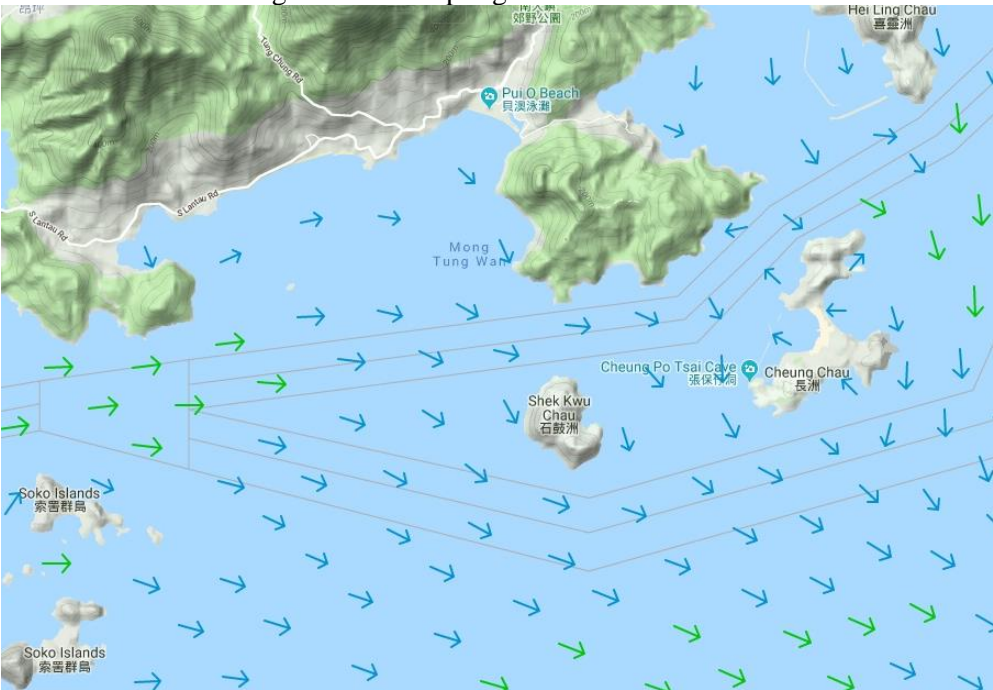
<p>Actions taken / to be taken</p>	<p>The two-double layers silt curtain for coral protection keep repairing. The Contractor was reminded to keep tracking on the status of the deployed silt curtain during construction works.</p> <p>Examination of environmental performance of the Project will be continued during the weekly inspection, and the Contractor is remained to implement all applicable mitigation measures as per the Updated EM&A Manual.</p>
<p>Remarks</p>	<p>Current direction during mid-ebb sampling on 18/09:</p>
