**Contract No. EP/SP/66/12**  
**Integrated Waste Management Facilities, Phase 1**  
**16<sup>th</sup> Quarterly EM&A Report**

# Quarterly EM&A Report No.16

## (Period from 1 April to 30 June 2022)

*(Clause 3.3, Further Environmental Permit FEP-01/429/2012/A)*

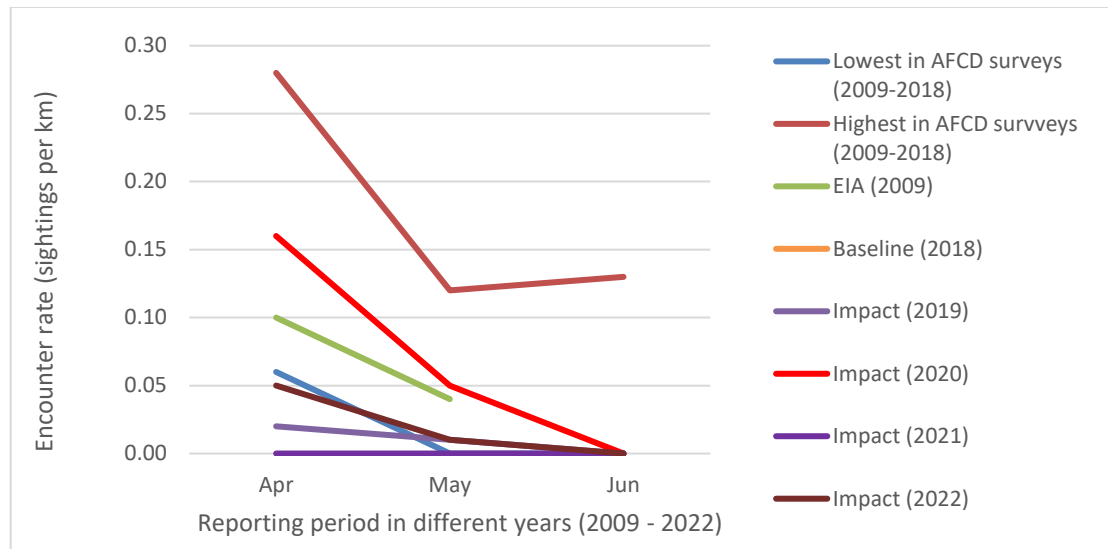
**Figure 6.5 Plot of encounter rate during April to June in 2009 – 2022 from different surveys**

6.3.1.4 A review of all the porpoise sightings in the survey area for April to June between 2009 and 2018 indicates that there are fluctuations between the number of sightings usually recorded in April, May and June. Given the similar survey conditions and the encounter rate recorded for porpoise in the project area during the reporting period, the encounter rate for April to June 2022 were between  $0.00\text{km}^{-1}$  and  $0.05\text{km}^{-1}$  (see Figure 6.5), it is noted that the encounter rates of impact survey in April and May 2022 were lower when compared to other years. The encounter rate of impact survey in June 2022 was the same as the impact monitoring in 2020 and 2021. It is noted that the impact survey focuses on a relatively small populations of highly mobile individuals and the survey area conducted for this monitoring is very small. It is also noted that works for other projects in the area adjacent to this Project site have been intensified, therefore, they are likely impacting porpoise presence and behaviour.
