**Contract No. EP/SP/66/12**  
**Integrated Waste Management Facilities, Phase 1**  
**Monthly EM&A Report No.88**

## **Monthly EM&A Report No.89**

### **(Period from 1 November to 30 November 2025)**

*(Clause 3.3, Further Environmental Permit FEP-01/429/2012/A)*

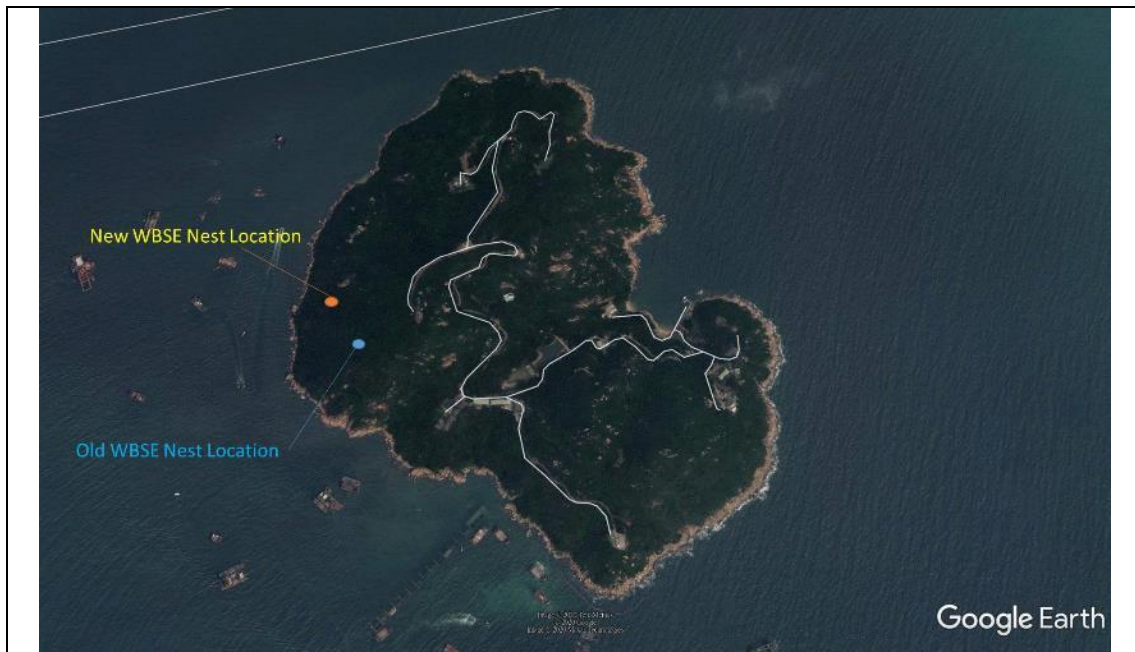
**Figure 7.1 Location of WBSE Nests on SKC**

7.5.2 During the whole monitoring survey period, the two adult WBSEs were recorded staying around the nest (new WBSE nest location) during the monitoring period and no chick was observed in the nest. No abnormal behaviors of the adults were recorded.
