Contract No. EP/SP/66/12
Integrated Waste Management Facilities, Phase 1
Monthly EM&A Report No.8

Monthly EM&A Report No.8 (Period from 1 February to 28 February 2019)

(Clause 3.3, Further Environmental Permit FEP-01/429/2012/A)

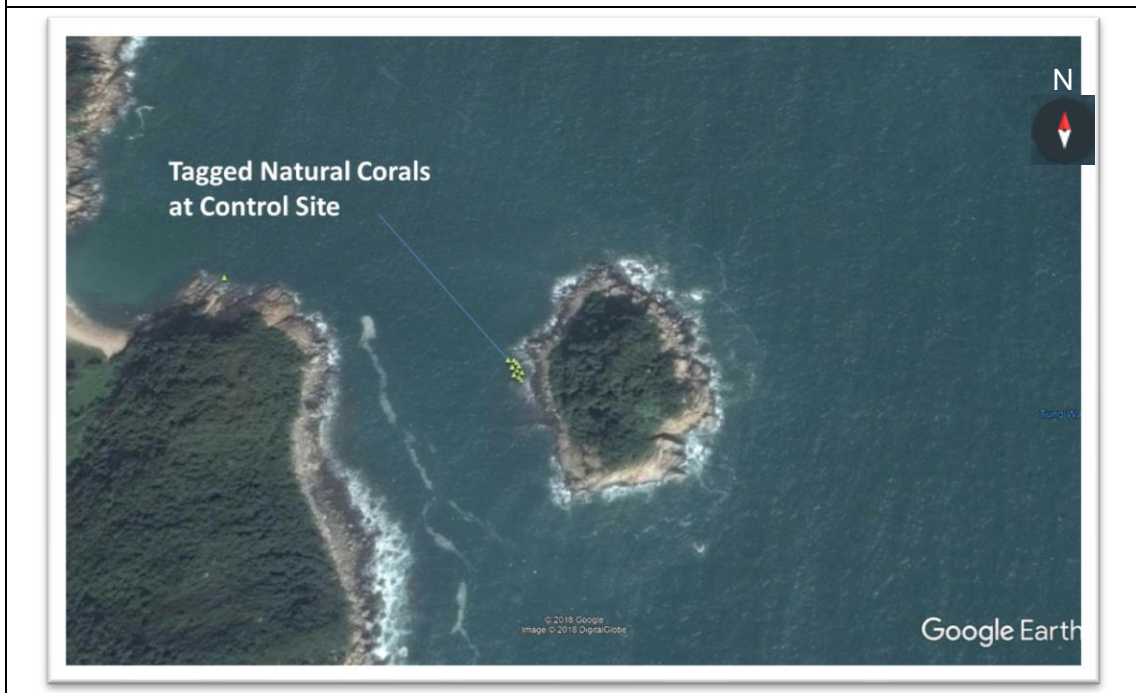
Figure 5.2 Tagged Natural Corals at Control Site Near Yuen Kong Chau for re-tagging after typhoon Mangkhut

5.3.1 Location of the ten tagged coral colonies at each of the proposed indirect impact site (re-tagging after typhoon Mangkhut), control site (baseline) and recipient site R3 (translocation) are shown in **Figure 5.1**, **Figure 5.2** and **Figure 5.3** respectively:

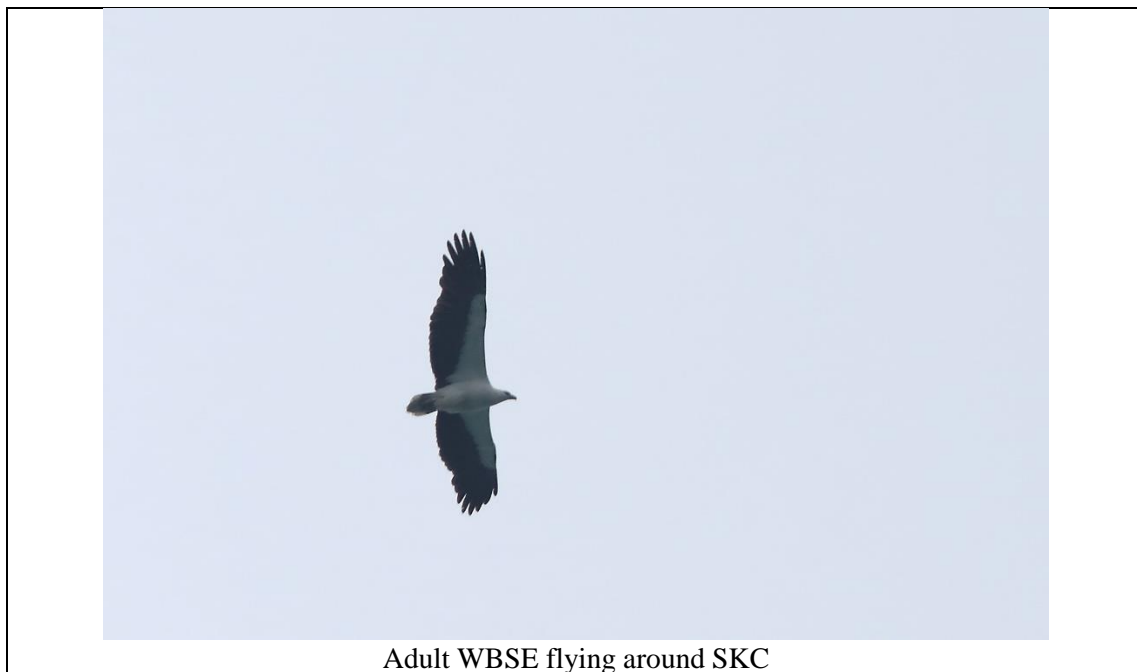
Figure 7.2 Photo Record of WBSE on SKC During the Reporting Period

7.5.3 No abnormal behavior of the recorded adults was observed during the February 2019 construction phase monitoring. Only two adults WBSE were recorded (**Figure 7.2**). All marine works during the eighth month construction period did not show any affects to the WBSE.

Adult WBSE flying around SKC

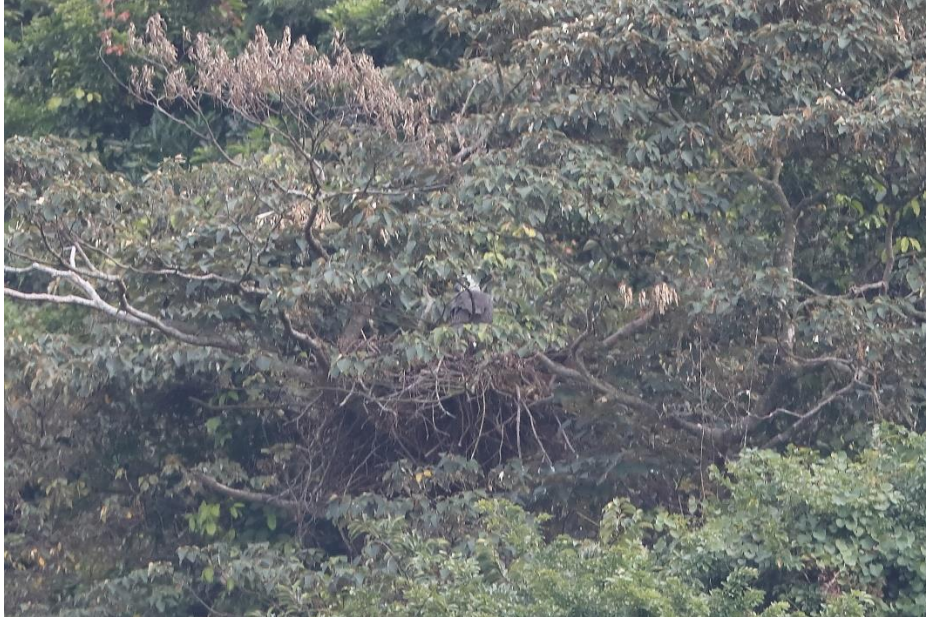
Adult WBSE staying at the Area next to its nest

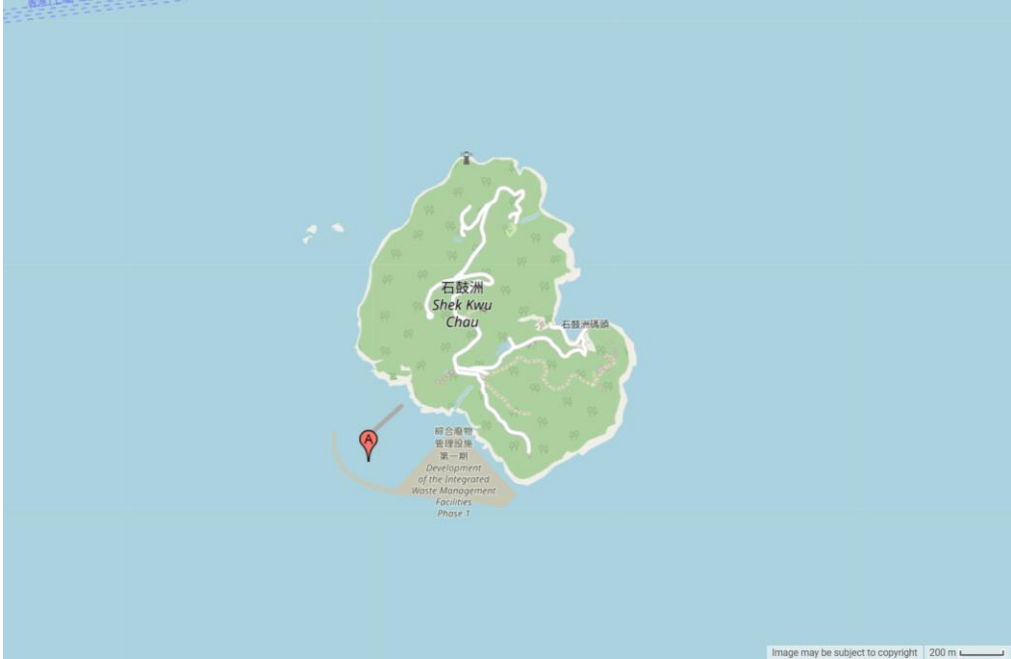
Project	Integrated Waste Management Facilities, Phase 1
Date	11 February 2019 (Lab result received on 18 February 2019)
Time	08:38 – 12:08 (Mid-Flood) 14:52 – 18:22 (Mid-Ebb)
Mid-Flood	
Monitoring Location	<p>II : A (N22°11.406 E113° 59.968)</p>

Action & Limit Levels	Action Level		Limit Level	
	≥ 2.7 mg/L (120% of average of UC1 & UC2)		≥ 3.0 mg/L (130% of average of UC1 & UC2)	
Measurement Level	Impact Station(s) of Exceedance	Control Stations		Impact Station(s) without Exceedance

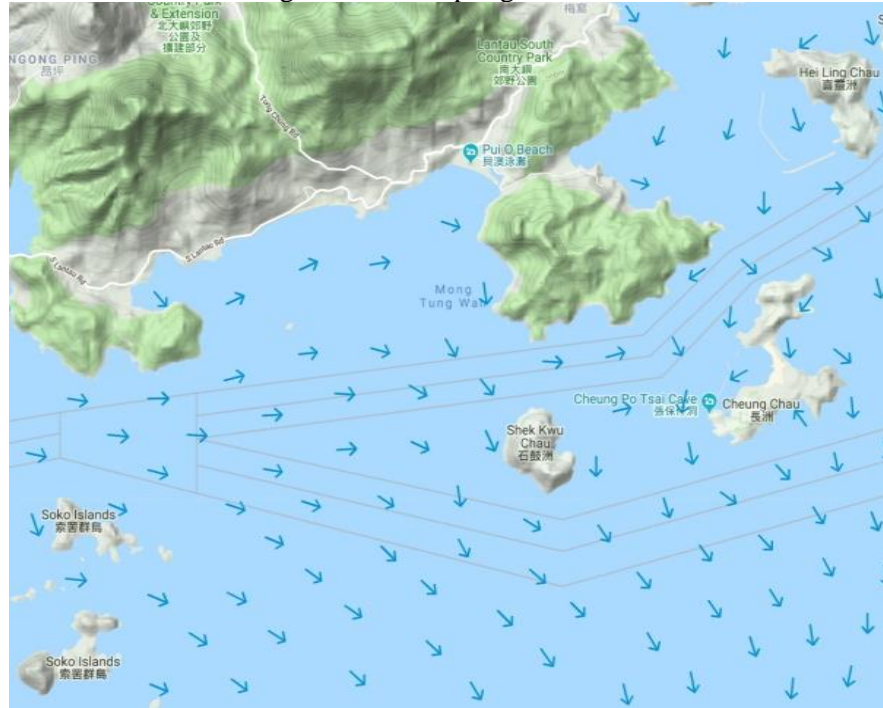
Current direction during mid-ebb sampling on 11/02:

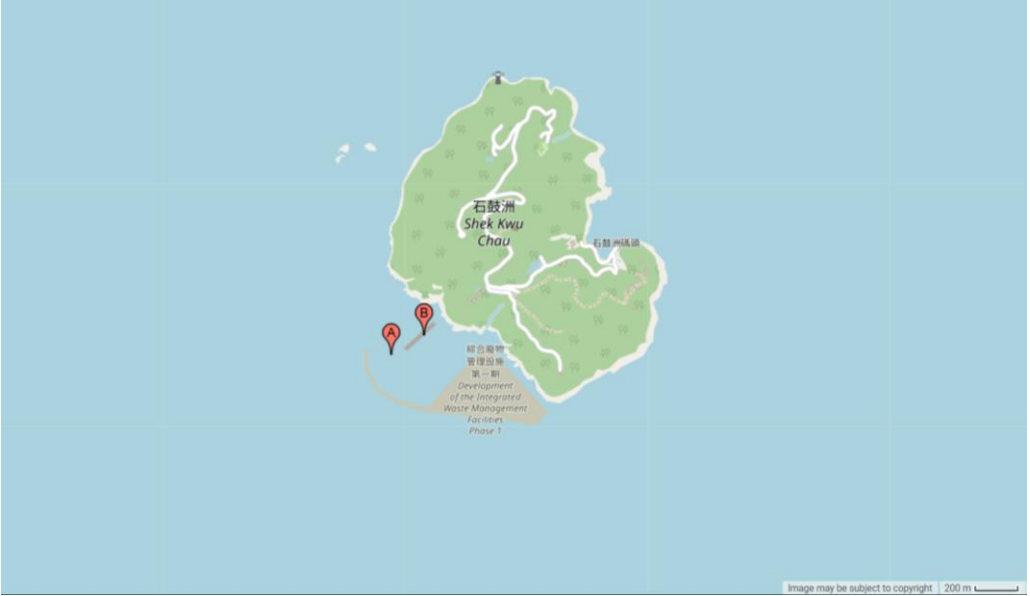
Project	Integrated Waste Management Facilities, Phase 1	
Date	12 February 2019 (Lab result received on 19 February 2019)	
Time	09:22 – 12:52 (Mid-Flood) 15:07 – 19:00 (Mid-Ebb)	
Mid-Flood		
Monitoring Location	<p>I6 : A (N22°11.406 E113° 59.968) I9 : B (N22°11.415 E113° 59.032)</p>

≥ 3.5 mg/L (120% of average of UC1 & UC2)	≥ 3.8 mg/L (130% of average of UC1 & UC2)	
Measurement Level	Impact Station(s) of Exceedance	Control Stations	Impact Station(s) without Exceedance

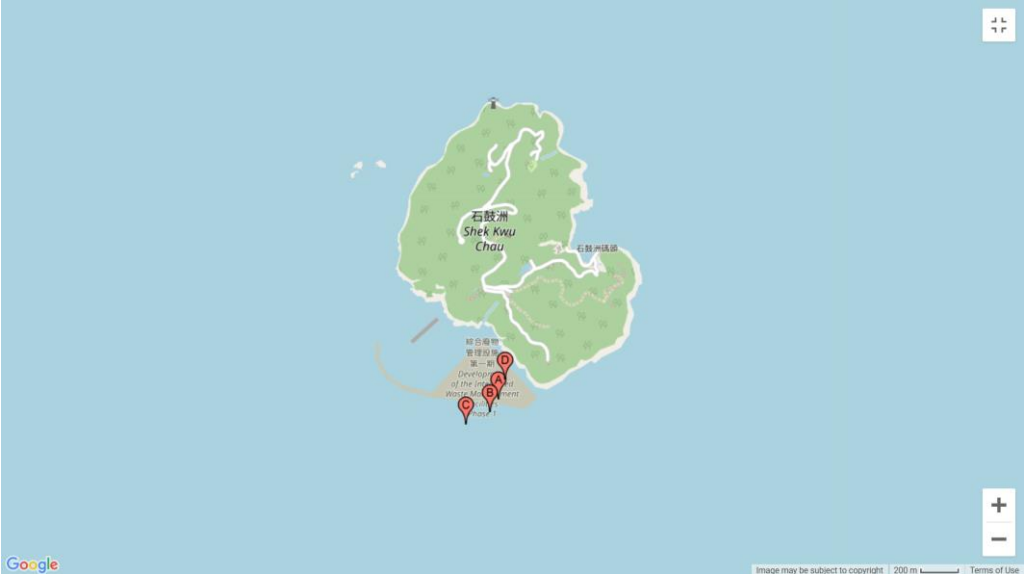
Project	Integrated Waste Management Facilities, Phase 1
Date	19 February 2019 (Lab result received on 21 February 2019)
Time	10:43 – 14:13 (Mid-Ebb) 14:54 – 19:00 (Mid-Flood)
Mid-Ebb	
Monitoring Location	I2 : A (N22°11.274 E113° 59.254) I3 : B (N22°11.238 E113° 59.228) I5 : C (N22°11.202 E113° 59.155) I6 : D (N22°11.329 E113° 59.274)

9.5 mg/L (I2) 9.3 mg/L (I3) 9.3 mg/L (I5) 9.2 mg/L (I6)	6.7 mg/L (UC1) 7.8 mg/L (UC2)	6.8 mg/L (I1) 7.3 mg/L (I4) 8.7 mg/L (I7) 8.2 mg/L (I8) 7.3 mg/L (I9) 8.7 mg/L (I10)
Possible reason for Action or Limit Level Non-compliance	<p>Works scheduled on site on 19/02 include sand blanket laying at caisson seawall area, post cone penetration test work, DCM sample coring, DCM main works and DCM plant trial.</p> <p>Dominating sea current direction was found to be from Northwest to Southeast at waters around Shek Kwu Chau.</p> <p>From MMO monitoring records on 19/02, MMO teams were arranged to two DCM barges (ESC-61 & ESC-62) and two derrick barge (FTB-19 & Kam Ying No.8) on that day while no deficiency of silt curtain was found before the start of construction activity.</p> <p>I2, I3, I5 & I6 are located close to the works location within the Project site while silt curtain checking was implemented on FTB-19 (07:00), Kam Ying (18:00), ESC-61 (10:30) and ESC-62 (00:00) by the Contractor and checking results showed that no deficiency of silt curtain was found on that day. No sand blanket laying work was carried out on Cheung Kee No.7 with referring to the site diary on that day. It might suggest that SS exceedances are deemed to be unrelated to the Project.</p>

Actions taken / to be taken	Examination of environmental performance of the Project will be continued during the weekly inspection, and the Contractor is remained to implement all applicable mitigation measures as per the Updated EM&A Manual.		
Mid-Flood			
Monitoring Location	<p>I1 : A (N22°11.283 E113° 59.016) I2 : B (N22°11.324 E113° 58.994) I3 : C (N22°11.363 E113° 59.011) I4 : D (N22°11.405 E113° 59.028) I9 : E (N22°11.453 E113° 58.974)</p>

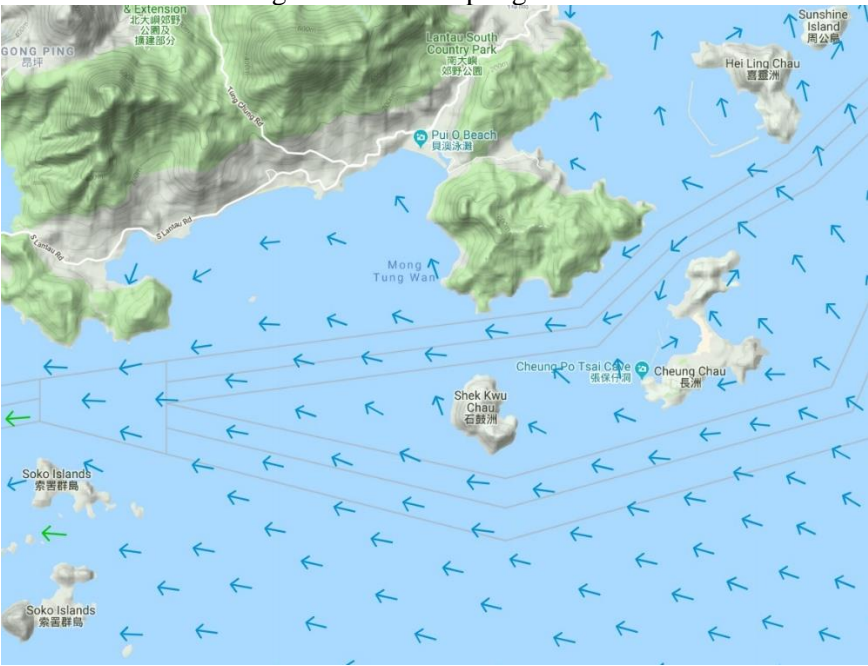
<p>Current direction during mid-flood sampling on 20/02:</p>

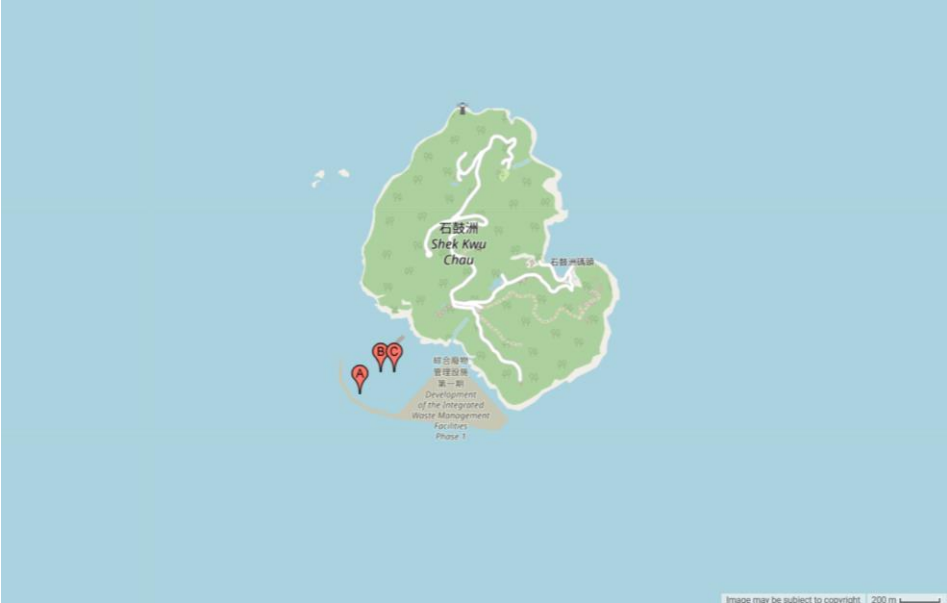
Project	Integrated Waste Management Facilities, Phase 1	
Date	22 February 2019 (Lab result received on 27 February 2019)	
Time	08:00 - 10:22 (Mid-Flood)	
Monitoring Location	Mid-Flood	
	I1 : A (N22°11.348 E113° 58.937) I3 : B (N22°11.407 E113° 59.000) I4 : C (N22°11.407 E113° 59.038)

≥ 2.6 mg/L (120% of average of UC1 & UC2)	≥ 2.8 mg/L (130% of average of UC1 & UC2)	
Measurement Level	Impact Station(s) of Exceedance	Control Stations	Impact Station(s) without Exceedance

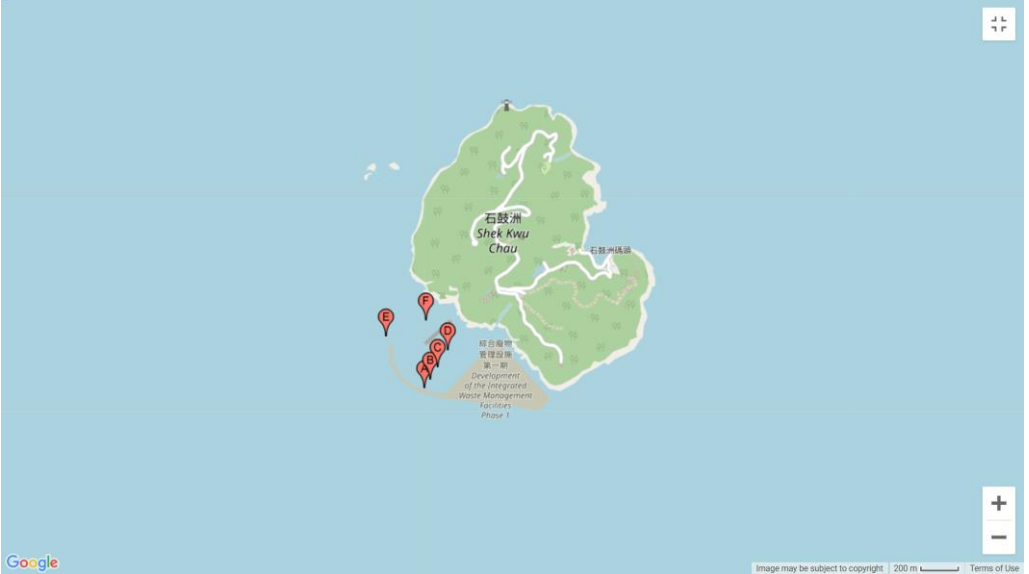
Project	Integrated Waste Management Facilities, Phase 1
Date	28 February 2019 (Lab result received on 7 March 2019)
Time	11:11 - 14:41 (Mid-Flood) 17:10 - 19:00 (Mid-Ebb)
Mid-Flood	
Monitoring Location	<p> I1 : A (N22°11.310 E113° 58.985) I2 : B (N22°11.334 E113° 59.001) I3 : C (N22°11.371 E113° 59.026) I4 : D (N22°11.419 E113° 59.057) I7 : E (N22°11.460 E113° 58.865) I10 : F (N22°11.505 E113° 58.990) </p>

Parameter	Suspended Solid (SS)		
Action & Limit Levels	Action Level		Limit Level
	≥ 4.2 mg/L (120% of average of UC1 & UC2)		≥ 4.6 mg/L (130% of average of UC1 & UC2)
Measurement Level	Impact Station(s) of Exceedance	Control Stations	Impact Station(s) without Exceedance
