Contract No. EP/SP/66/12
Integrated Waste Management Facilities, Phase 1
Monthly EM&A Report No.90

Monthly EM&A Report No.90
(Period from 1 December to 31 December 2025)

(Clause 3.3, Further Environmental Permit FEP-01/429/2012/A)

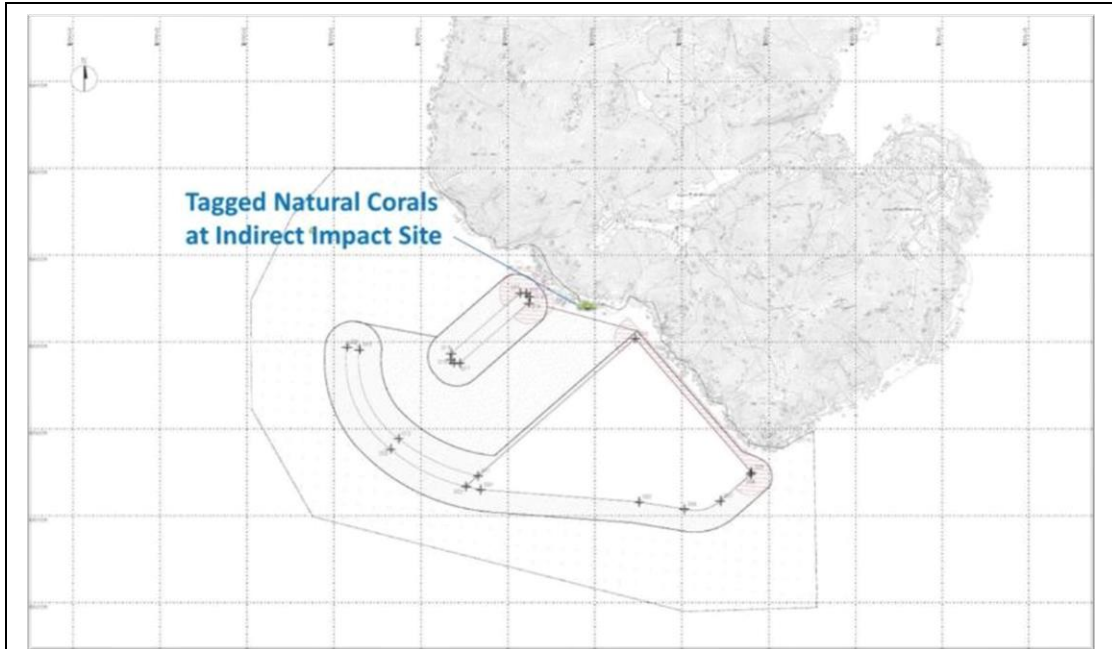
Figure 5.1 Tagged Natural Corals at Indirect Impact Site Near SKC for re-tagging after typhoon Mangkhut

5.3.1 Location of the ten tagged coral colonies at each of the proposed indirect impact site (re-tagging after typhoon Mangkhut), control site (baseline) and recipient site R3 (translocation) are shown in **Figure 5.1**, **Figure 5.2** and **Figure 5.3** respectively:

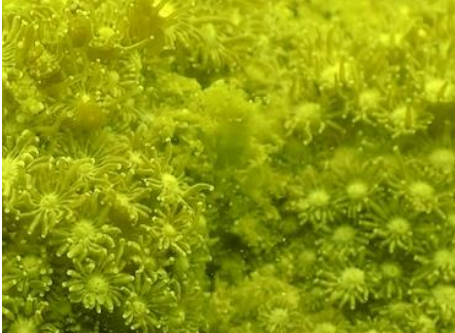
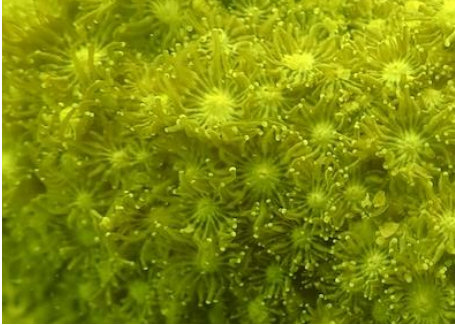
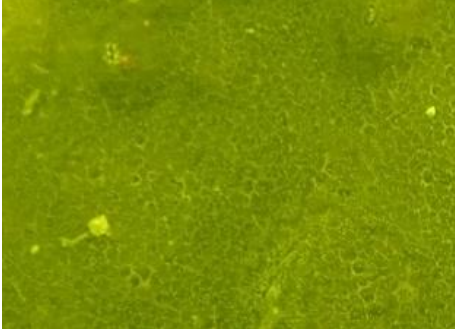
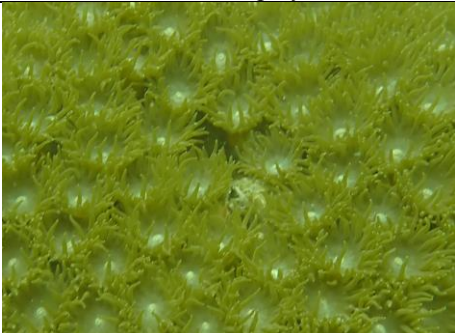
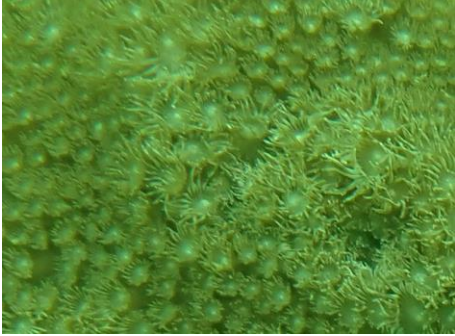
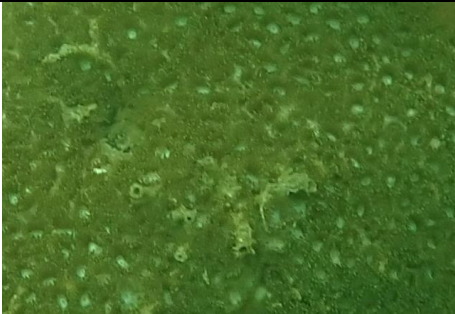
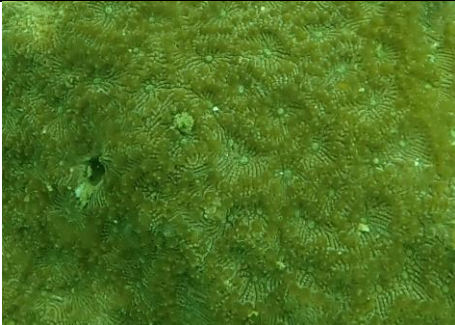
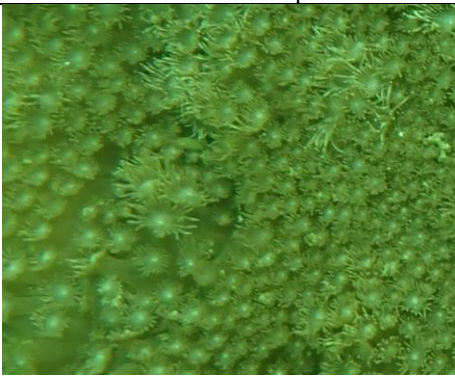
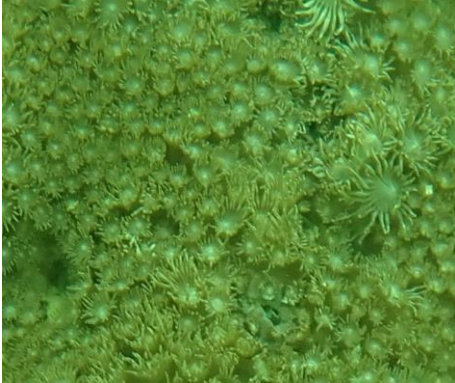
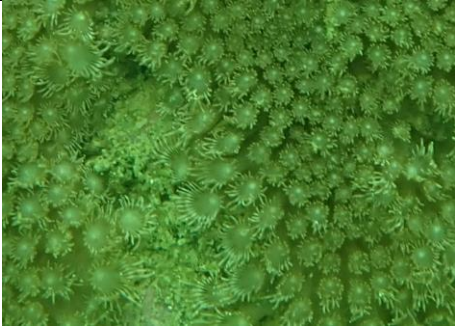
Photo Plate 5.1 Ten (10) Monitored Corals at Control Site

5.7.2 Ten (10) hard coral colonies were monitored at each Control site and Indirect Impact Site as suggested in the Construction Phase Monitoring Plan. The general health conditions (size, mortality, bleaching and sediment) were recorded and summarized in **Table 5.8** and **Table 5.9**. Photos of each coral colonies were taken during the monitoring activities shown in **Photo Plate 5.1** and **Photo Plate 5.2**.

Tag #	Species	Size (cm) – Max. Diameter	Condition	Mortality (%)		Bleaching (%)		Sediment (%)	
				Baseline	17/12	Baseline	17/12	Baseline	17/12
1	<i>Goniopora stutchburyi</i>	25	Good	0	0	0	0	0	0
2R	<i>Goniopora stutchburyi</i>	10	Good	0	0	0	0	0	0
3	<i>Psammocora superficialis</i>	18	Good	0	0	0	0	0	0
4	<i>Turbinaria peltata</i>	13	Good	0	0	0	0	0	0
5R	<i>Goniopora stutchburyi</i>	18	Good	0	0	0	0	0	0
6	<i>Cyphastrea serailia</i>	43	Good	0	0	0	0	0	0
7R	<i>Coscinaraea</i> sp.	15	Good	0	0	0	0	0	0
8	<i>Goniopora stutchburyi</i>	21	Good	0	0	0	0	0	0
9	<i>Goniopora stutchburyi</i>	11	Good	0	0	0	0	0	0
10R	<i>Goniopora stutchburyi</i>	20	Good	0	0	0	0	0	0

- 5.7.4 All tagged and re-tagged coral colonies showed good health condition during the 28th Quarterly Construction Phase Monitoring. There was no increased level of mortality, bleaching and sediment when compared with the baseline results.

- 5.7.5 No sediment, bleaching or increased mortality in the general condition of coral colonies were observed during the tenth construction phase monitoring period. No deterioration of the coral community was observed in the ecological monitoring results when compared with the baseline ecological monitoring results. There is no AL/LL exceedance during the monitoring period. Photos of each tagged corals colonies were taken and shown in **Photo Plates 5.1** and **Photo Plate 5.2**.

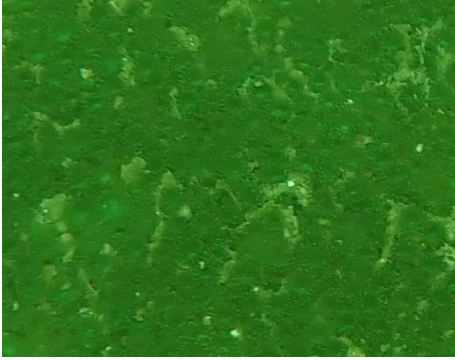
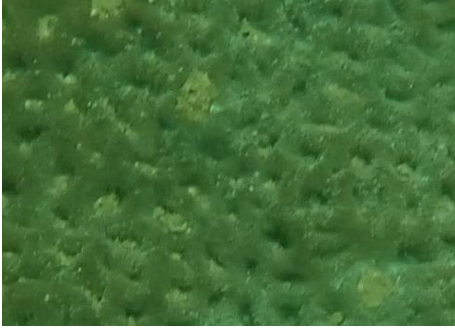
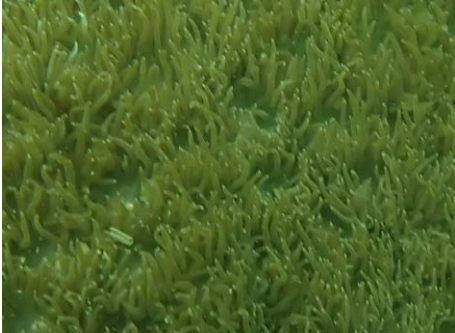
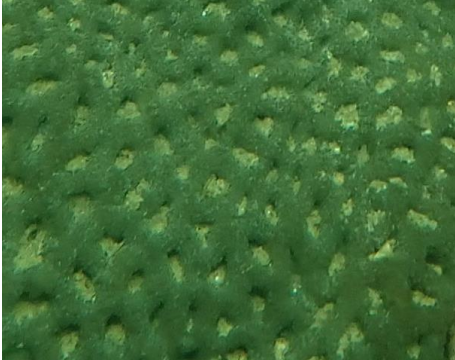
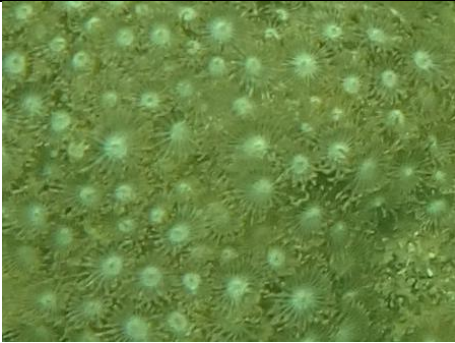
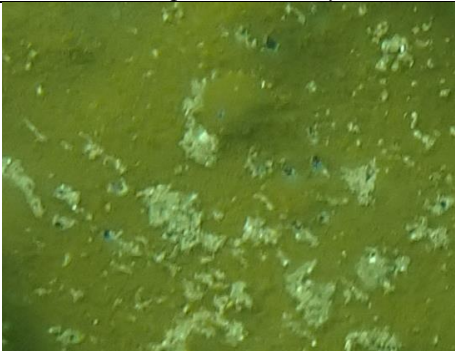
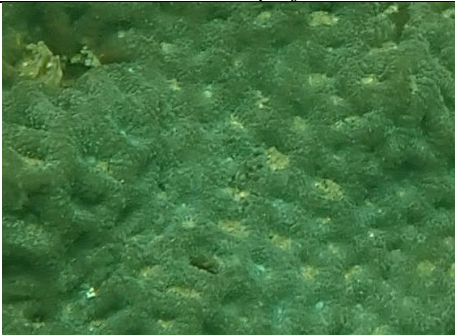
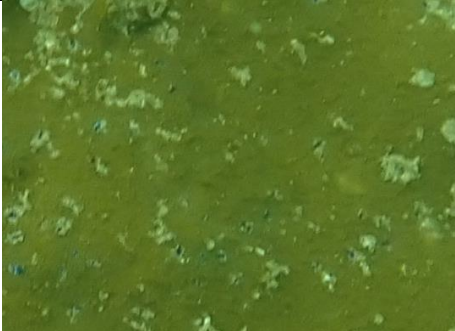
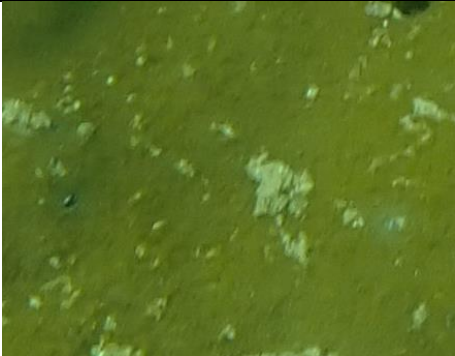
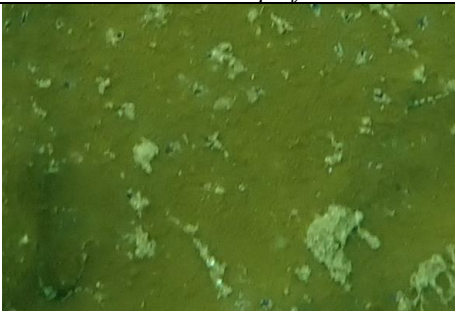
Photo Plate 5.2 Ten (10) Monitored Corals at Indirect Impact Site

Tag #	Species	Size (cm) – Max. Diameter	Condition	Mortality (%)		Bleaching (%)		Sediment (%)	
				Baseline	17/12	Baseline	17/12	Baseline	17/12
11R	<i>Cyphastrea serailia</i>	48	Good	0	0	0	0	0	0
12R	<i>Favites chinensis</i>	27	Good	0	0	0	0	0	0
13R	<i>Turbinaria peltata</i>	21	Good	0	0	0	0	0	0
14R	<i>Favites chinensis</i>	8	Good	0	0	0	0	0	0
15R	<i>Goniopora stutchburyi</i>	11	Good	0	0	0	0	0	0
16R	<i>Psammocora superficialis</i>	27	Good	0	0	0	0	0	0
17R	<i>Favites chinensis</i>	15	Good	0	0	0	0	0	0
18R	<i>Psammocora superficialis</i>	39	Good	0	0	0	0	0	0
19R	<i>Psammocora superficialis</i>	42	Good	0	0	0	0	0	0
20R	<i>Psammocora superficialis</i>	29	Good	0	0	0	0	0	0

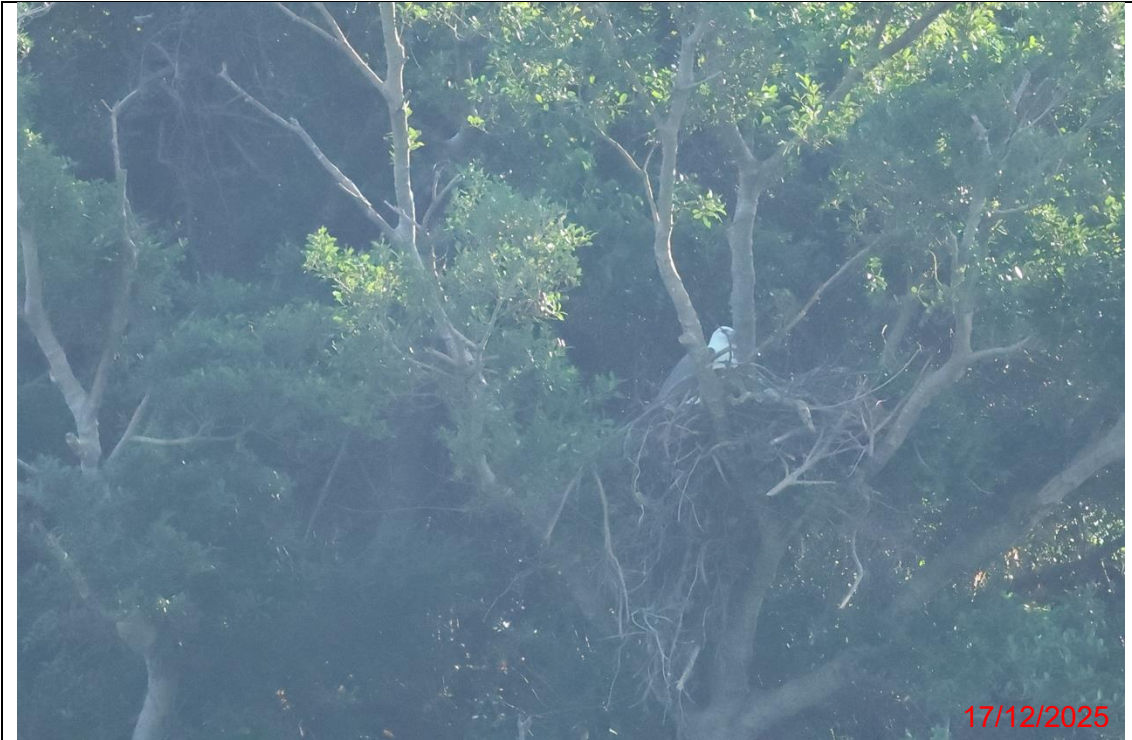
WBSE Adult recorded in the new Nest on 17th December 2025

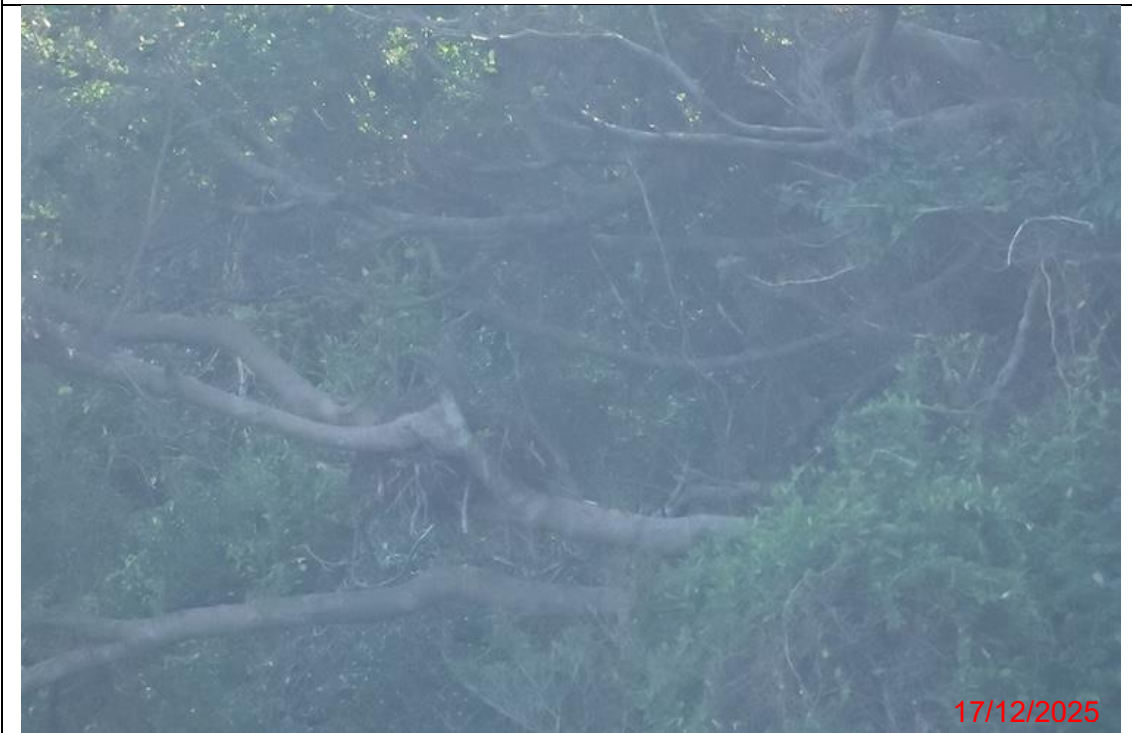
The Abandoned old Nest

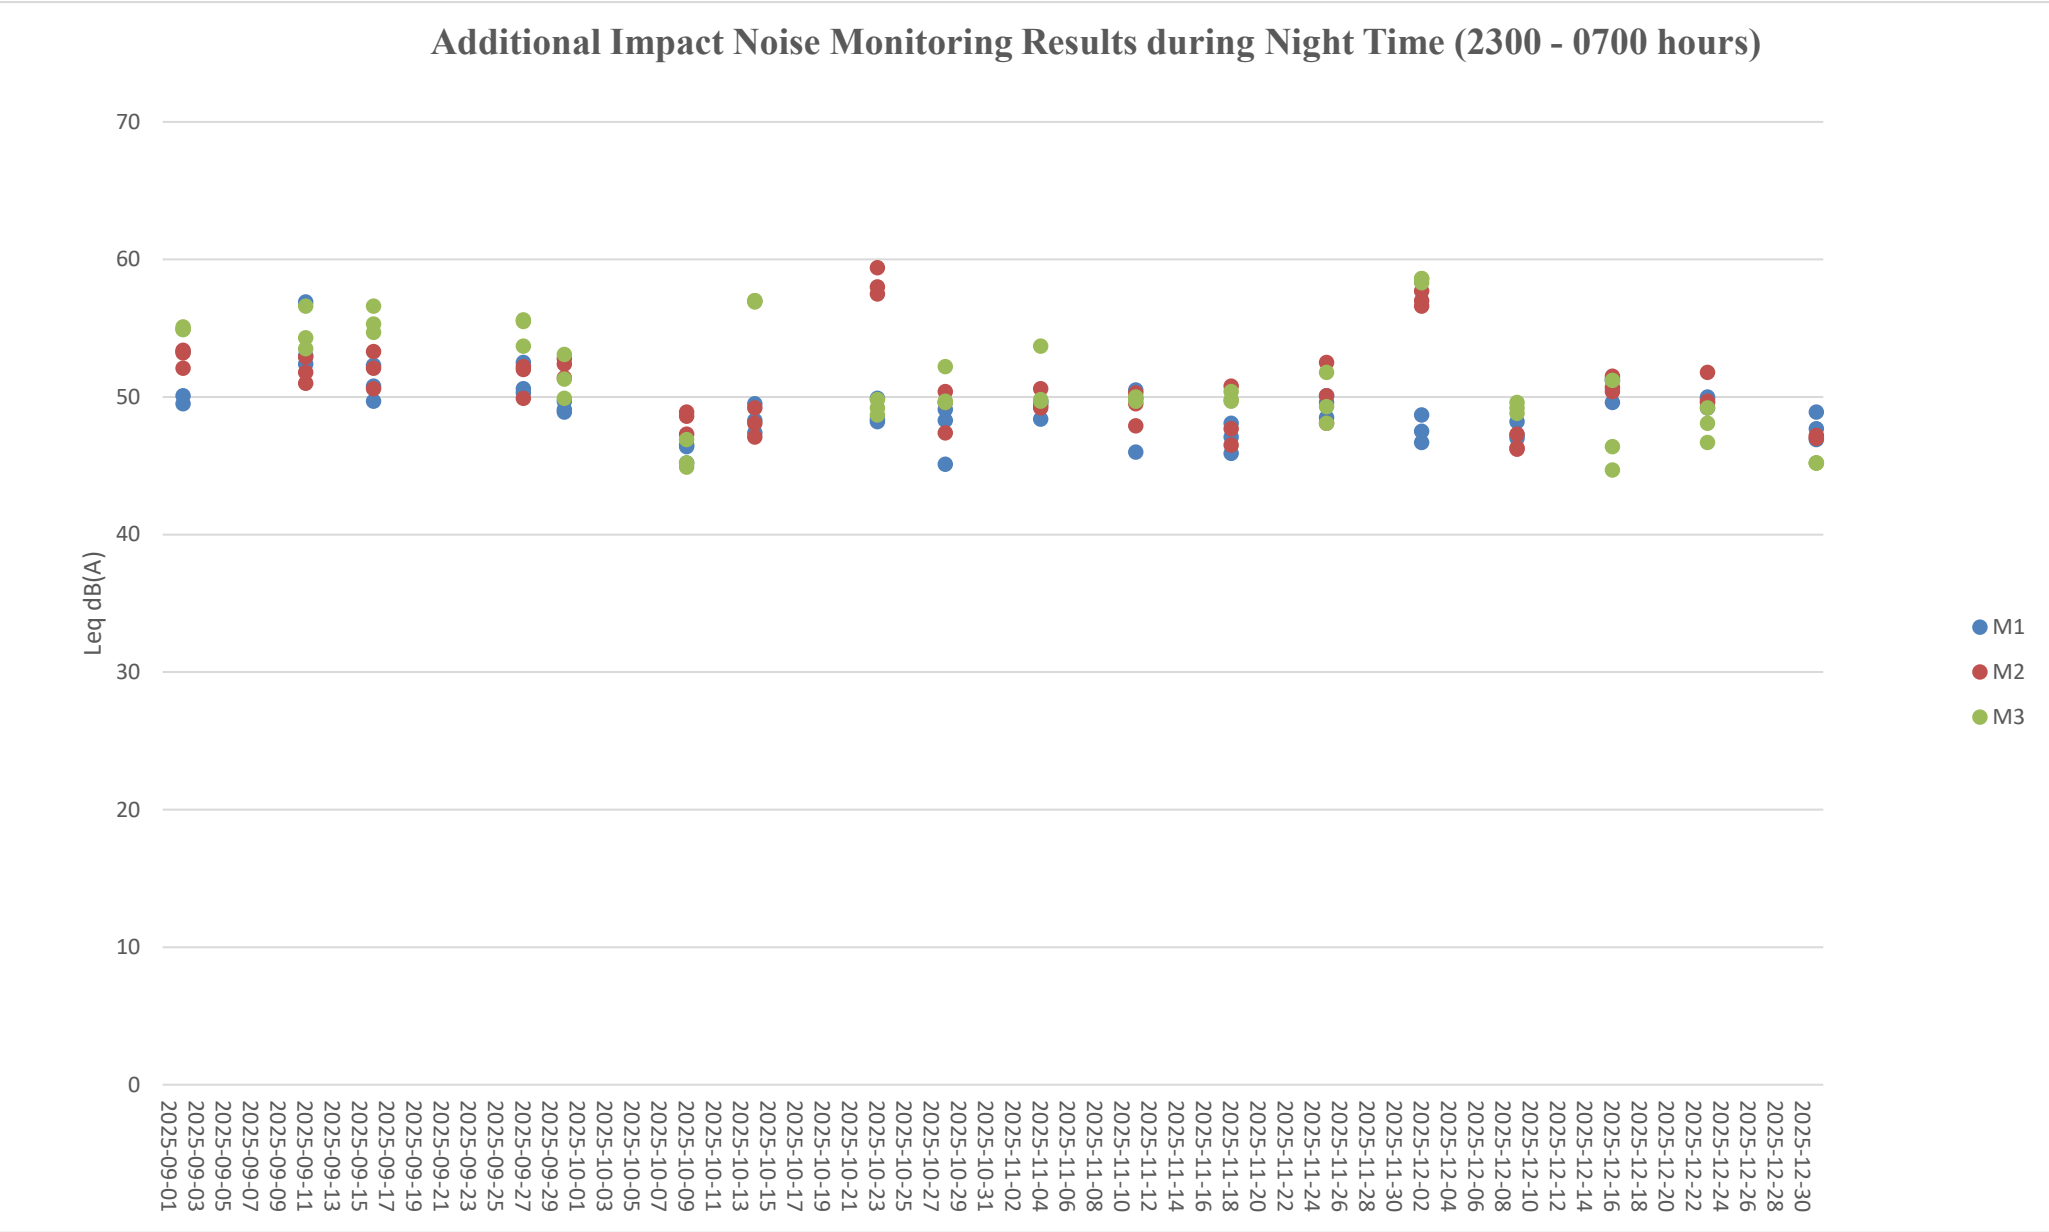
Additional Impact Noise Monitoring Results during Night Time (2300 - 0700 hours)

1. Construction works carried out during reporting month refer to **Table 1.2**.
2. Weather condition recorded and noise source other than construction activities from the Project observed during the monitoring events refer to noise monitoring data summary in **Appendix G**.
