**Contract No. EP/SP/66/12**  
**Integrated Waste Management Facilities, Phase 1**  
**Monthly EM&A Report No.93**

## Monthly EM&A Report No.93 (Period from 1 March to 31 March 2026)

*(Clause 3.3, Further Environmental Permit FEP-01/429/2012/A)*

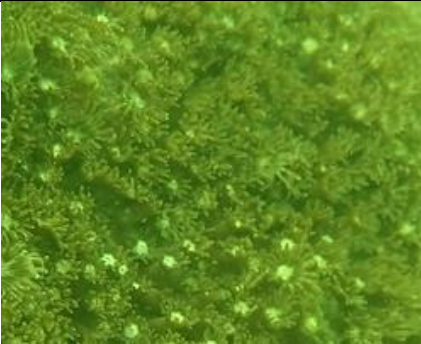
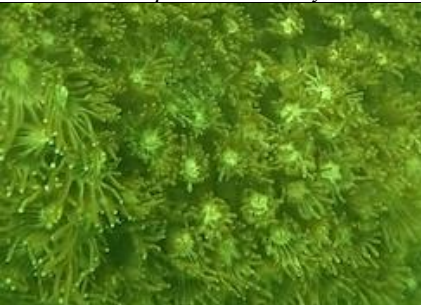
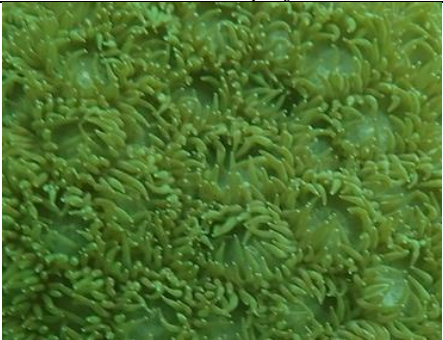
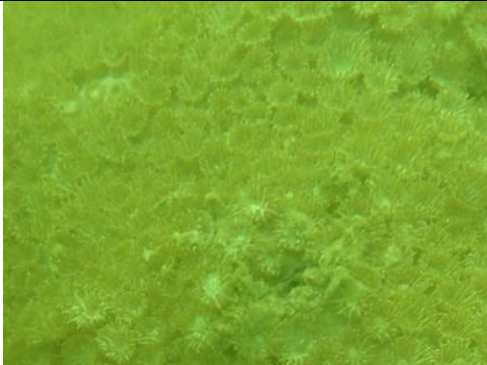
**Photo Plate 5.1      Ten (10) Monitored Corals at Control Site**

5.6.2 Ten (10) hard coral colonies were monitored at each Control site and Indirect Impact Site as suggested in the Construction Phase Monitoring Plan. The general health conditions (size, mortality, bleaching and sediment) were recorded and summarized in **Table 5.8** and **Table 5.9**. Photos of each coral colonies were taken during the monitoring activities shown in **Photo Plate 5.1** and **Photo Plate 5.2**.

- 5.6.4 All tagged and re-tagged coral colonies showed good health condition during the 29<sup>th</sup> Quarterly Construction Phase Monitoring. There was no increased level of mortality, bleaching and sediment when compared with the baseline results.

- 5.6.5 No sediment, bleaching or increased mortality in the general condition of coral colonies were observed during the tenth construction phase monitoring period. No deterioration of the coral community was observed in the ecological monitoring results when compared with the baseline ecological monitoring results. There is no AL/LL exceedance during the monitoring period. Photos of each tagged corals colonies were taken and shown in **Photo Plates 5.1** and **Photo Plate 5.2**.
